# Lake Kowhai

## *Baseline Assessment Summary Report*

**Date:** 20 July 2021

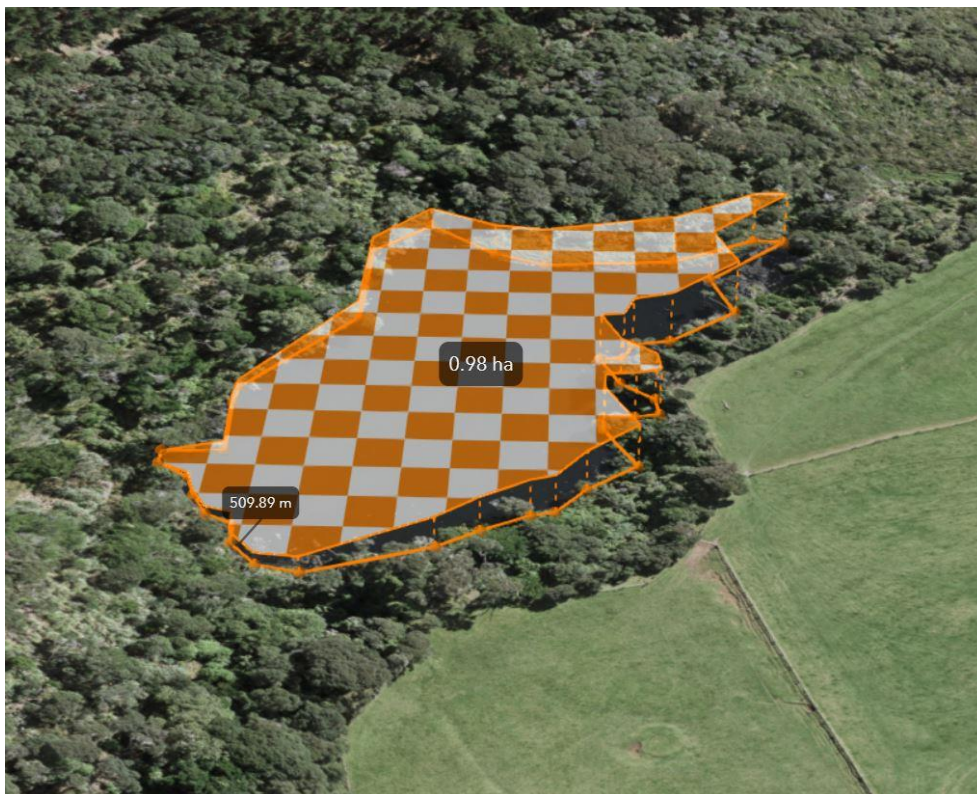
This lake is part of the Kaipara South Head Dune Lake Complex and has a total area of 0.98 ha and a perimeter of 509.89 m. The maximum depth recorded was 5.8 m and the mean depth is approximately 3.5 m, majority of the lake is between 1 to 3 m deep.

**Figure 1:** Map indicating the total lake area and perimeter.

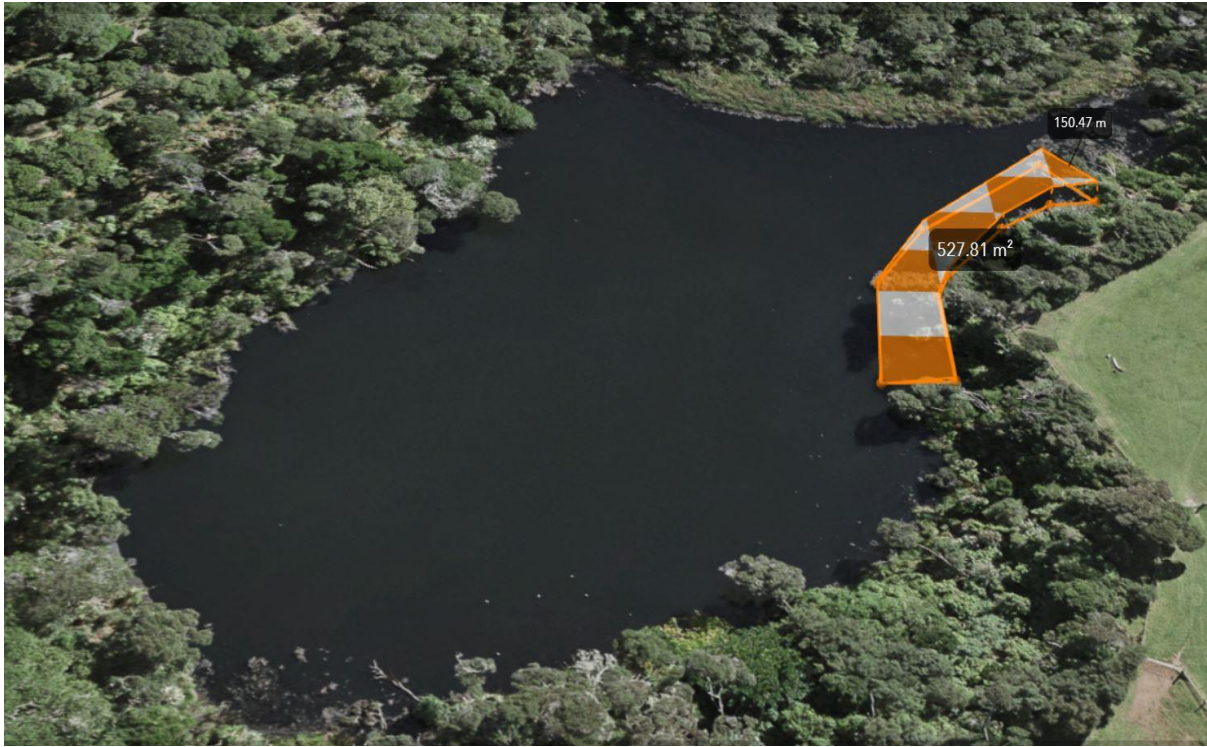
The biggest biosecurity impact/pressure in this lake is the *Egeria*, the other pest species exist in low enough numbers that they are unlikely to cause a significant effect. The *Egeria* is largely confined to an approximately 500 m<sup>2</sup> area along the north east bank. Again, the high degree of shading around the littoral margins has confined majority of the biomass to the north facing bank with the least amount of shading. *Egeria* prefer moderate to high light conditions and relatively warm temperatures. The shading around majority of the lake and lack of human access/recreational use has hampered the spread of *Egeria* throughout the lake. That being said the risk of lake-wide spread is high and if left untouched the *Egeria* biomass could increase exponentially and overrun the lake.

**Figure 6:** Map indicating *Egeria densa* incursion area

Mitigating eutrophication in-lake is challenging without a comprehensive understanding of sediment and water quality parameters. It is recommended that water quality and sediment samples are taken seasonally to establish a baseline understanding of the nutrient dynamics in the lake, this information will guide further in-lake interventions. The immediate actions that can be taken are the removal of *Egeria densa* from the lake, this incredibly invasive species contributes to nutrient enrichment and the formation of anoxic conditions. The *Egeria* is currently contained to the northeast section of the lake and can be removed by hand, if it is not removed soon there is a high chance it will spread throughout the lake. If *Egeria* is allowed to establish across the lake, removal/eradication will be extremely difficult and impossible in some cases.

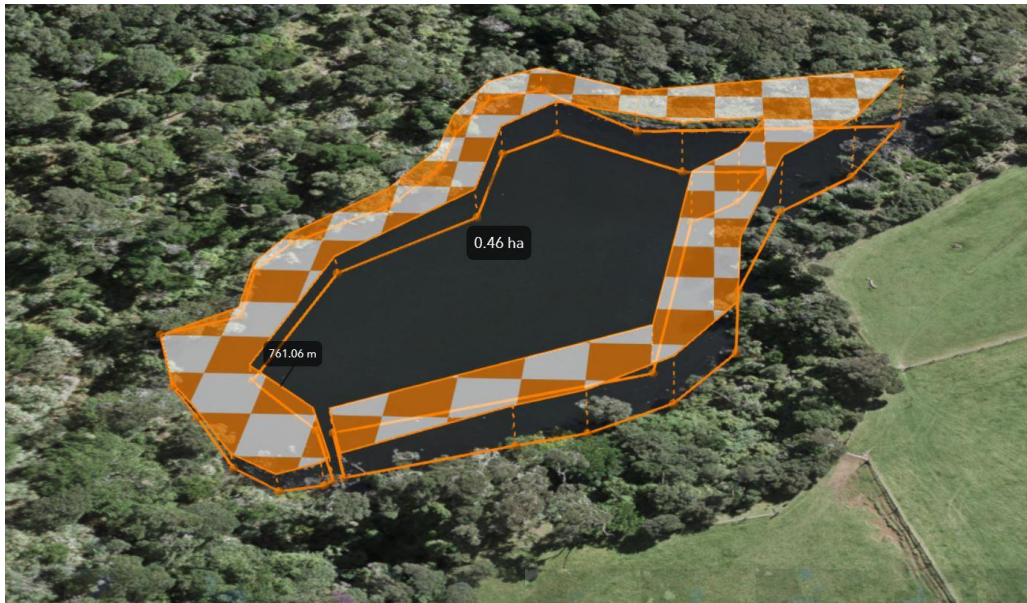
Lake Kowhai can be delimited into two dominant zones, namely the littoral zone and the limnetic zone. The littoral zone is the shallow areas along the margins of the lake and is largely defined by the macrophyte extent which extends to an average depth of 4 m. The limnetic zone starts past this depth and extends to the maximum lake depth, this zone encompasses the deeper (4 – 5.8 m) centre portion of the lake.

**Figure 7:** Map indicating the littoral zone of the lake

Majority of the in-lake biodiversity and habitat is found within the littoral zone. The emergent riparian vegetation (reed line) marks the start of this zone. The macrophyte beds are well defined and constrained to specific depth contours. The charophytes formed dense beds from the edge of the reed line (0.5 – 1 m depth) down to a maximum extent of 4.5 m, the mean lower charophyte extent was 3 m deep. The pond weeds formed a line that mirrored the 3 – 4 m depth contour with sporadic stands down to a maximum depth of 5 m. There is a large amount of tree debris throughout the littoral zone which serves as substrate for sponges and algal growth, *Nitella* species are also commonly found draped over submerged tree debris.

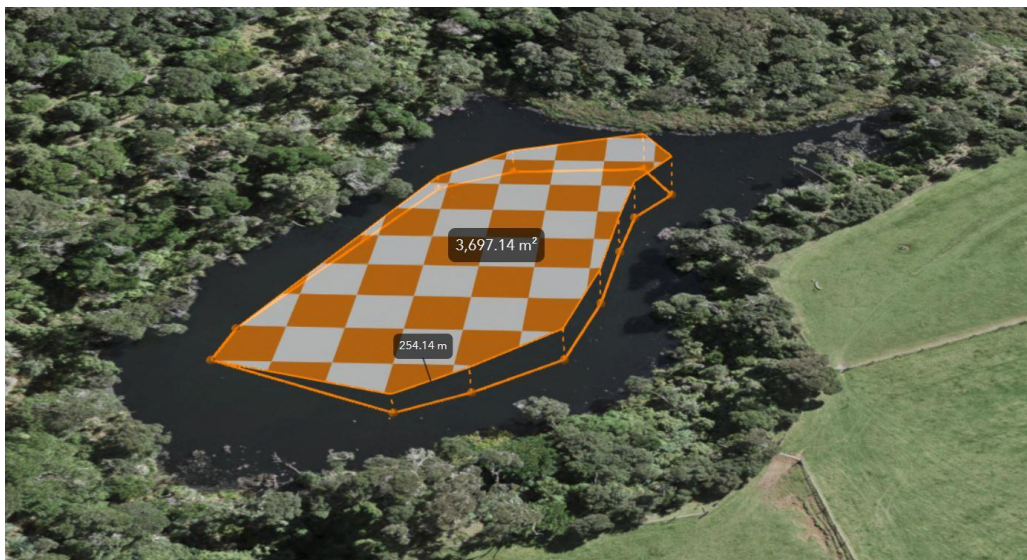
**Figure 8:** Map indicating the limnetic zone of the lake

The limnetic zone is the deepest region of the lake (5 – 5.8 m) and is largely devoid of macrophyte growth. Large areas of the sediment surface in this zone are covered by benthic algal mats. Benthic algal mats are common throughout the lake but are persistent at 5 m or deeper. There is a marked change in substrate that defines the start of this zone, the sediment changes from a fine sand to a very fine silt and mud complex. The top layer of sediment consists of a surficial layer of fine organic silt
