Lake Rotoroa

Invasive Macrophyte

Assessment March 2022

Prepared for: Kathryn Gale - Ngāti Pāhauwera

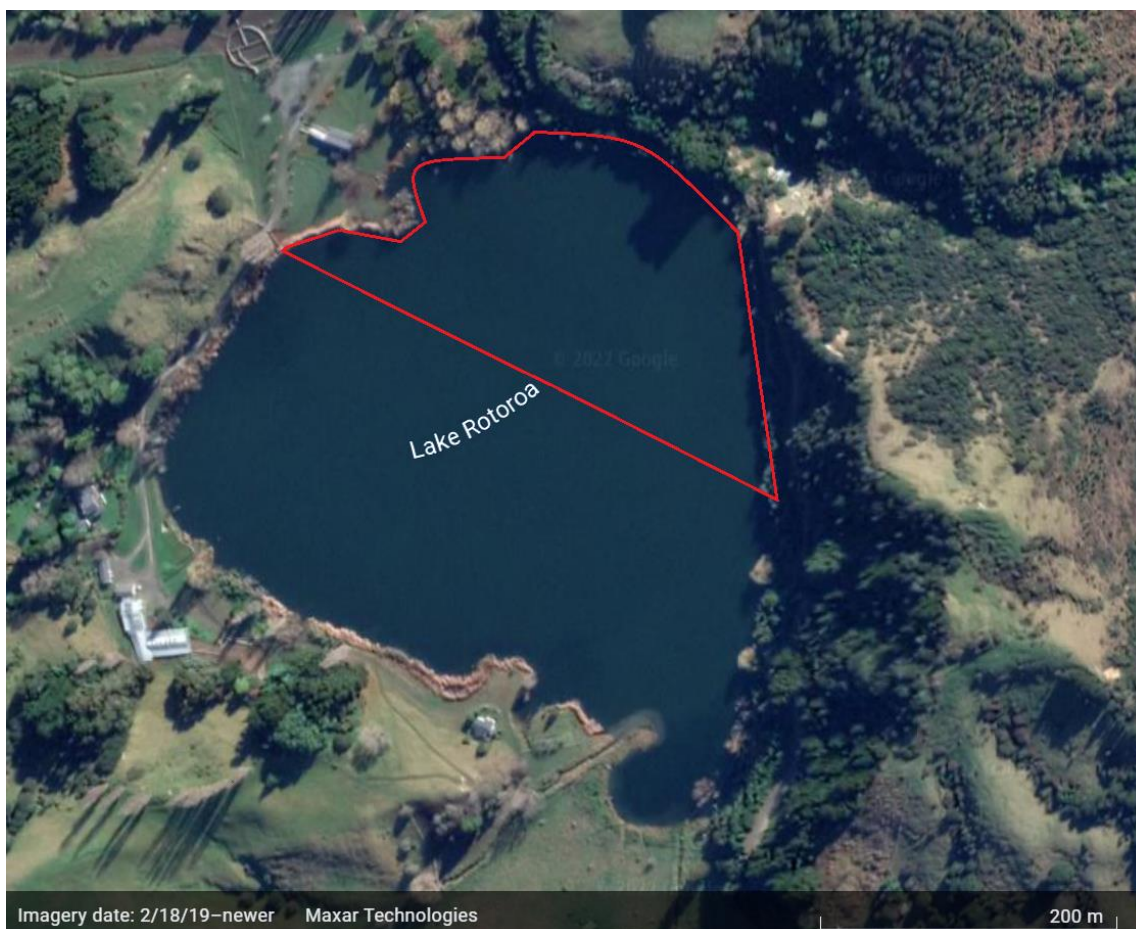
Figure 1: Lake Rotoroa survey area

Our survey, conducted on the 3rd of January 2022, was restricted to the northern half of the lake (Figure 1) where we found Hornwort had already formed large, dense beds across the littoral zone making it the dominant macrophyte species in this area. Anecdotal evidence suggests that the southern part of the lake had less invasive macrophyte growth and that the northern section was the most densely colonised area. This could be a result of flow, there is an outlet on the northern tip of the lake so macrophyte propagules/fragments could be washed toward the northern end of the lake where they settle and establish. Further surveys are needed to confirm this.

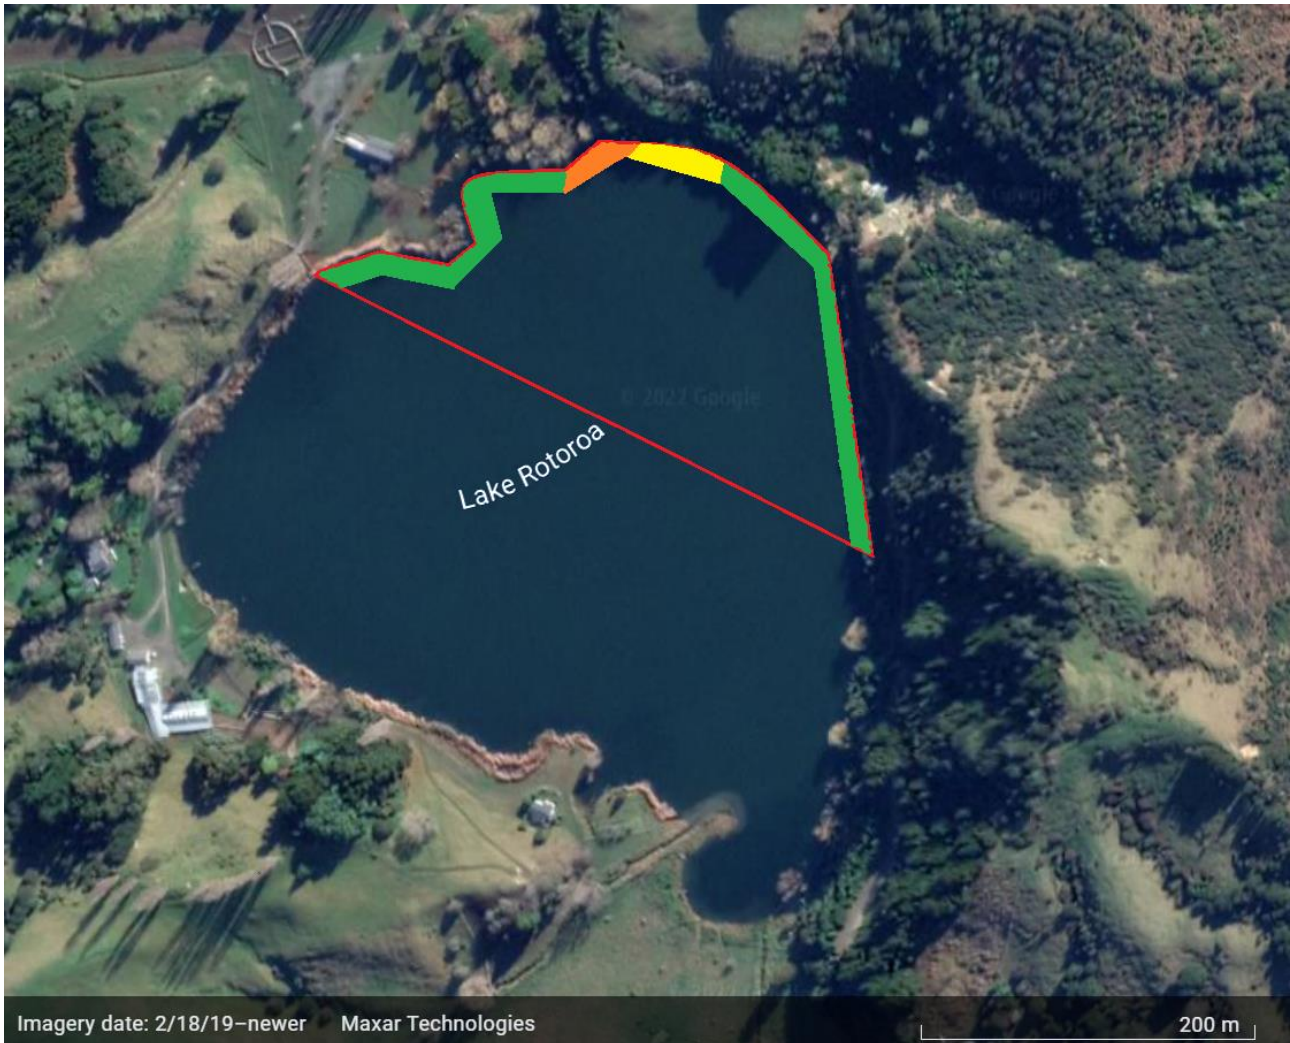
Hornwort beds formed an almost continuous band around the survey area extending from the lake margin to a maximum depth of 8 m (Figure 2). Past 6.4 m deep the Hornwort beds begin to die off and there was a noticeable drop in overall plant condition as we approached the maximum depth extent. The upper extent of the Hornwort beds was variable, in some areas the beds started past the emergent riparian vegetation (1 – 1.5 m deep) and in others directly adjacent to the bank (0.5 m).

Figure 2: Approximate macrophyte delimitation – green areas represent dense Hornwort beds, orange areas represent dense Elodea beds and yellow areas represent moderate cover of Elodea.

Elodea, while more contained than Hornwort, had also formed well established beds along the littoral areas in the northern section of the lake (Figure 2). These beds were discrete in nature with well-defined boundaries. Elodea beds tended to occur in shallow areas (0.5 – 2m) around emergent raupō beds (*Typha orientalis*) and sandy slopes that run along the northern bank. The lower extent was much shallower than the Hornwort with a maximum depth extent of 2.5 m, this could be a result of light limitation.

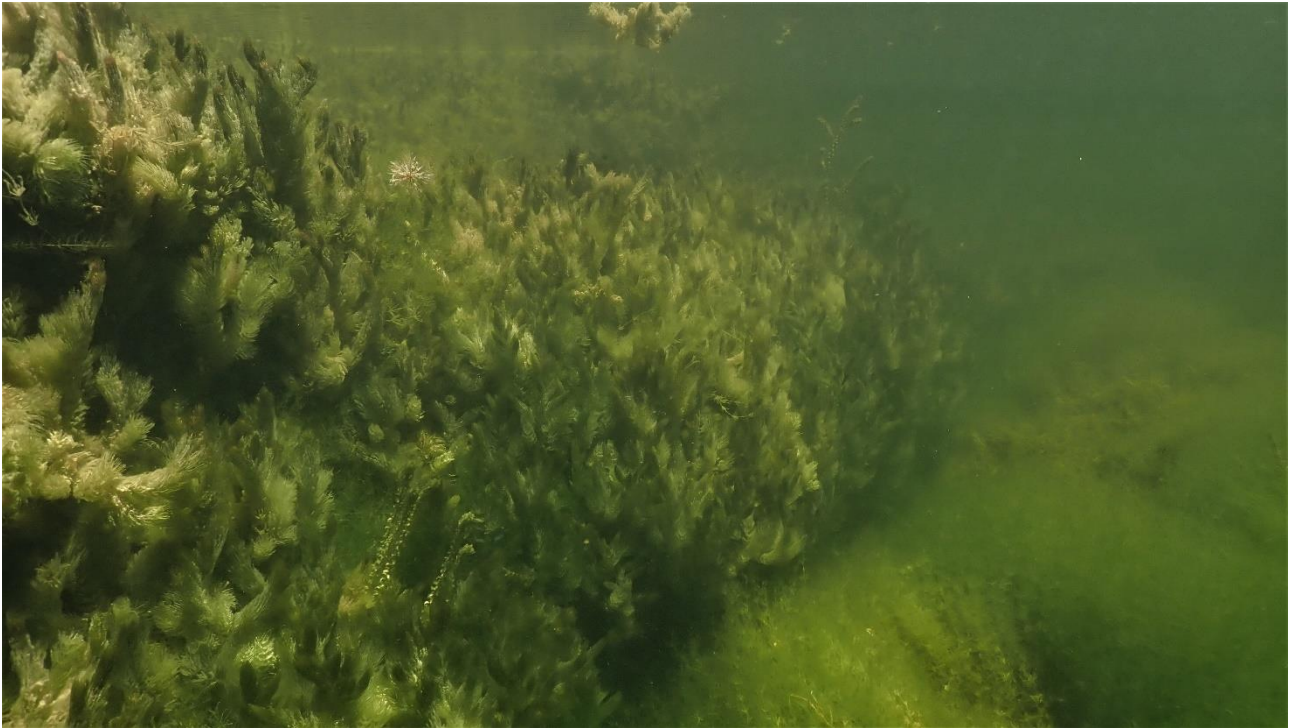
Image 1: Upper extent of Hornwort in shallow area adjacent to native charophyte meadows

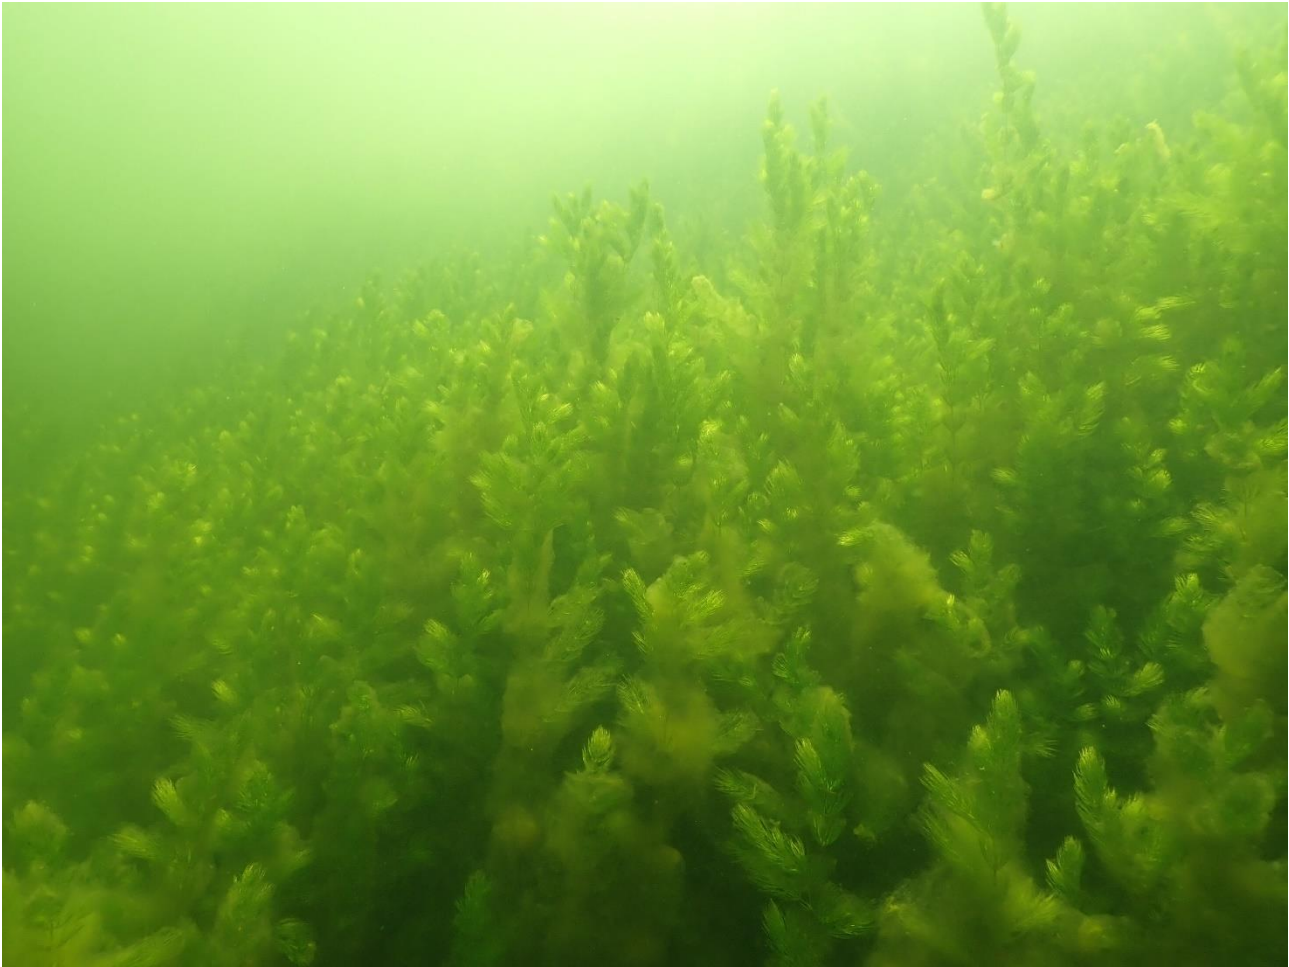
Image 2: Mid-section of a dense Hornwort bed sloping from the shallows to the lower extent

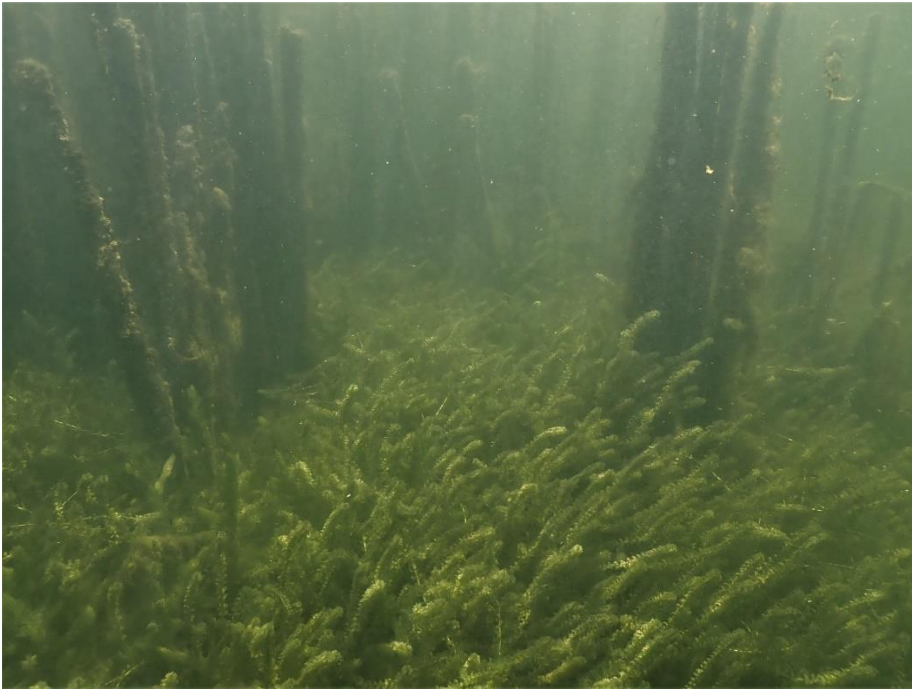
Image 6: Upper extent of Elodea – Elodea beds extending into the emergent riparian vegetation

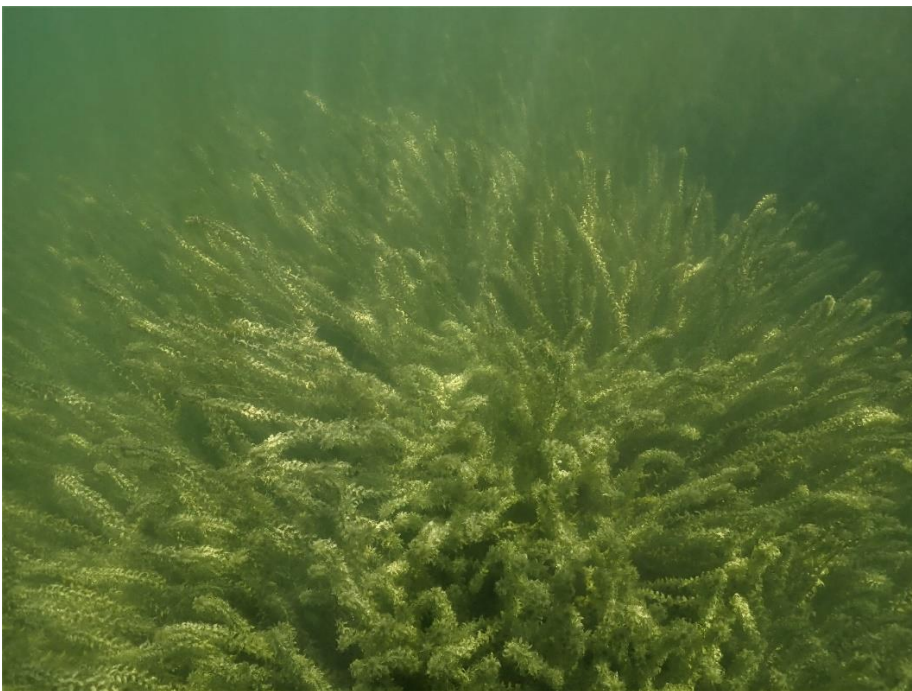
Image 7: Lower extent of Elodea – tall growing Elodea at 2.5 m deep

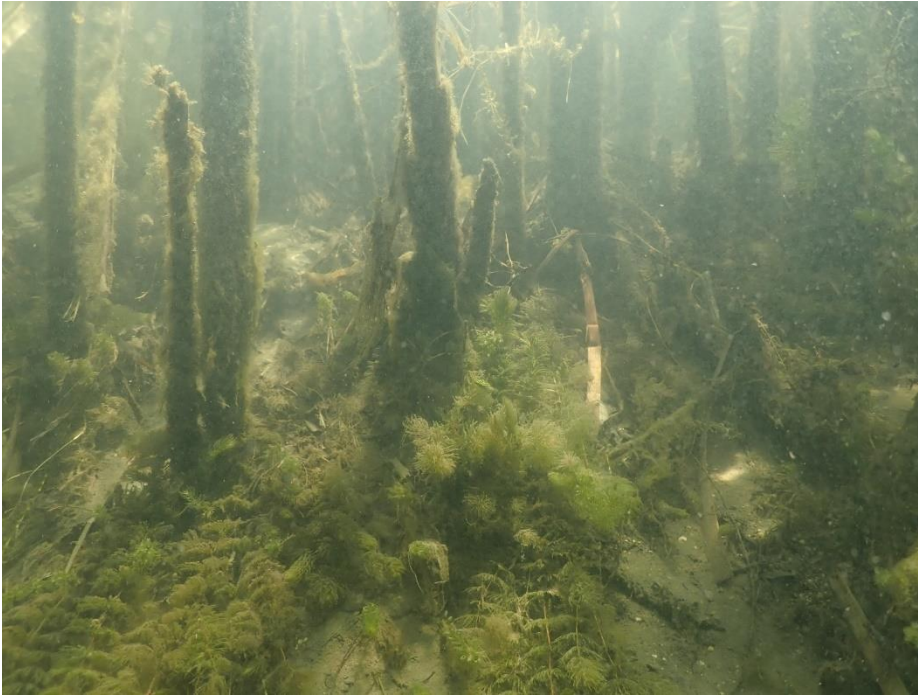
Image 8: Native *Myriophyllum* adjacent to the emergent riparian vegetation

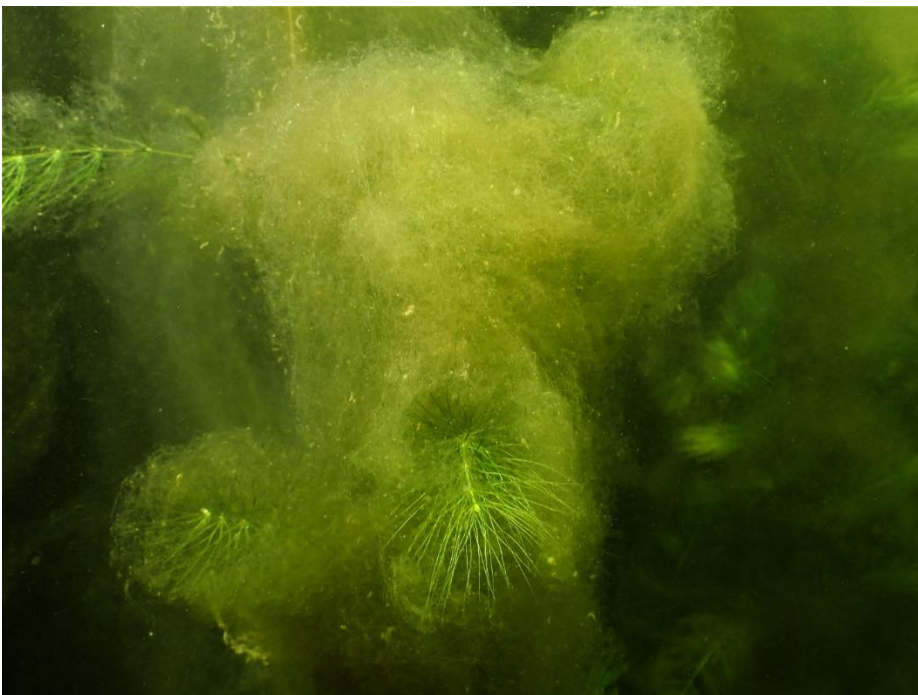
Image 9: *Myriophyllum* covered with epiphytic algae

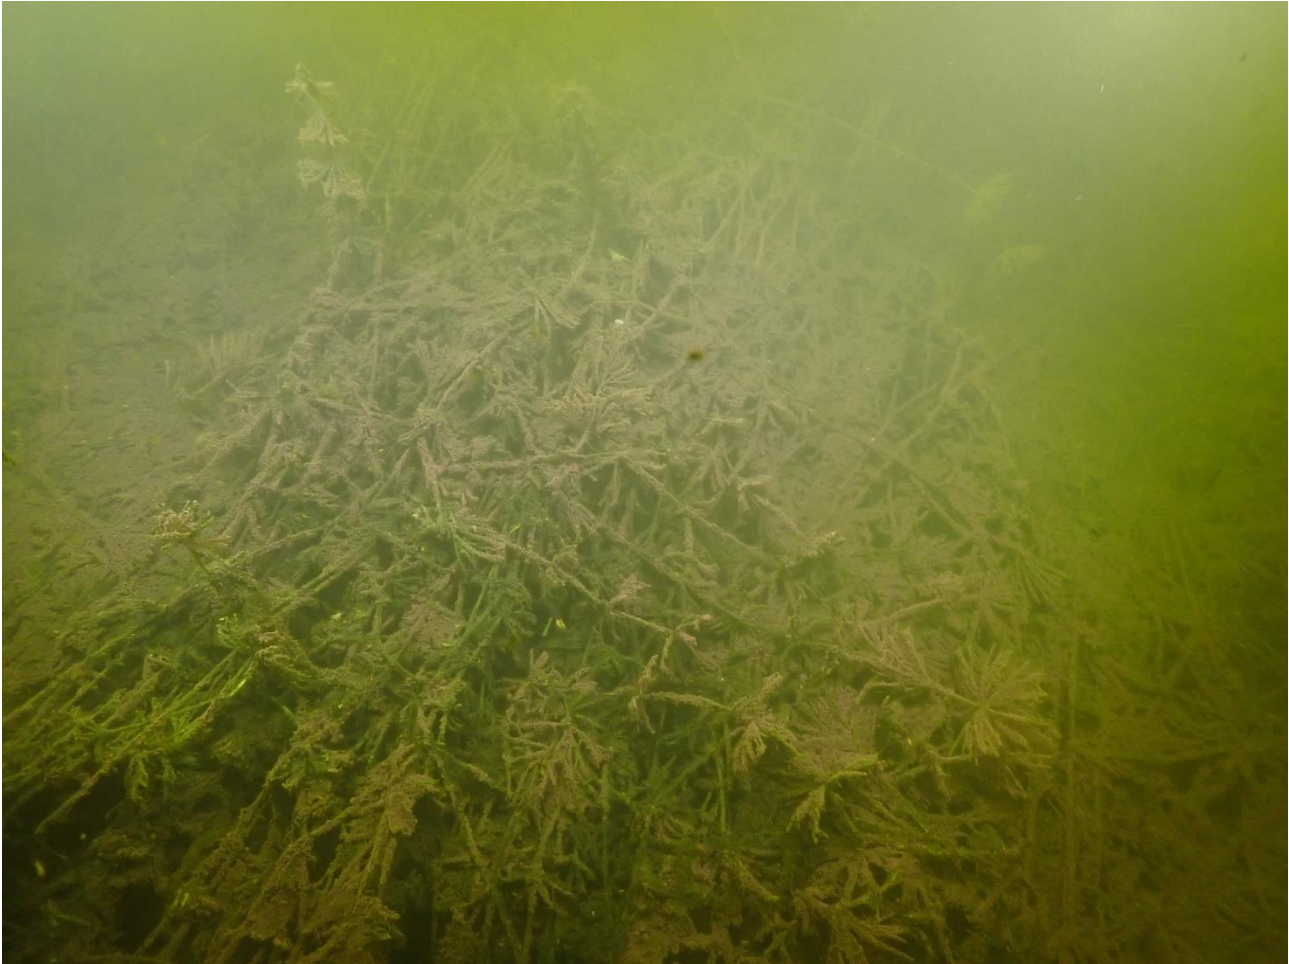
Ammonia in low concentration across short periods can promote Hornwort growth while chronic exposure is toxic (Best, 1980; Eliašová et al., 2021). Pulses of ammonia are common in lakes surrounded by agricultural and livestock land use activities which could have contributed to the rapid Hornwort colonisation. Past 6 m deep there is a build-up of decomposing organic material, majority of which is dead Hornwort. This decomposition

leads to anoxia and increased sediment ammonia concentrations both of which limit Hornwort growth. This creates a degree of self-regulation and may contribute to maintaining a steady biomass.

Image 11: Thick layer of decomposing Hornwort and organic material in the deeper sections of the lake – the haze seen in the photo is a sulphur precipitate

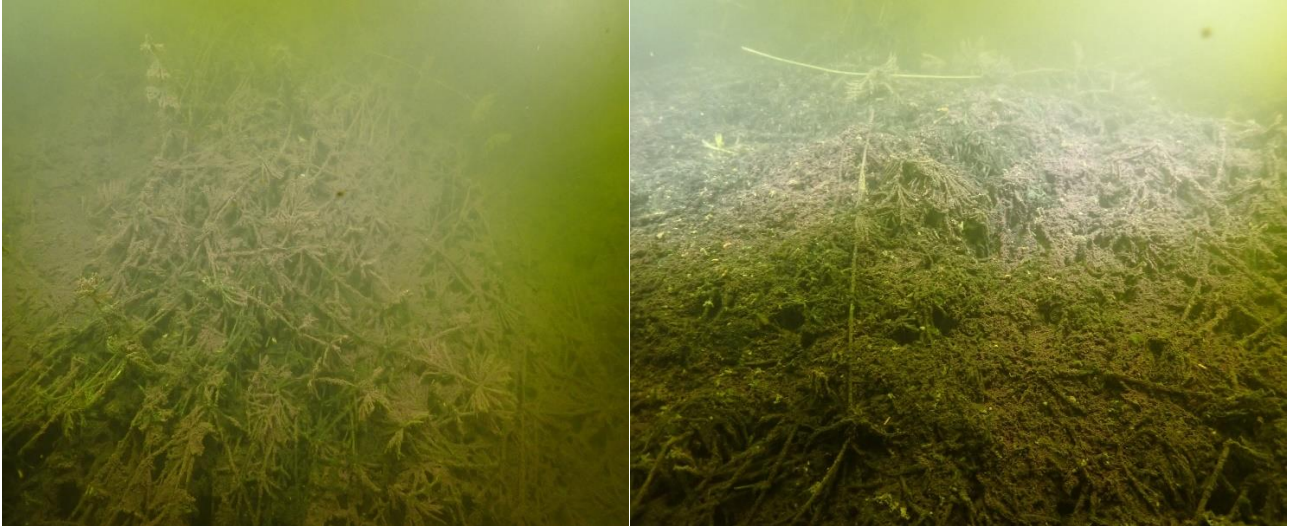
The sediment characteristics in Lake Rotoroa change along a depth gradient. The sandy beaches surrounded by Raupō have limited surficial organic silt. The substrate becomes muddy within the dense macrophyte beds with a thick layer of organic silt. Past 6 m the Hornwort begins to die off and there is an extensive layer of dead Hornwort material, this layer was up to 30 cm thick along the lower boundary of the dense Hornwort beds.

Image 12: Thick layer of decomposing Hornwort and organic silt

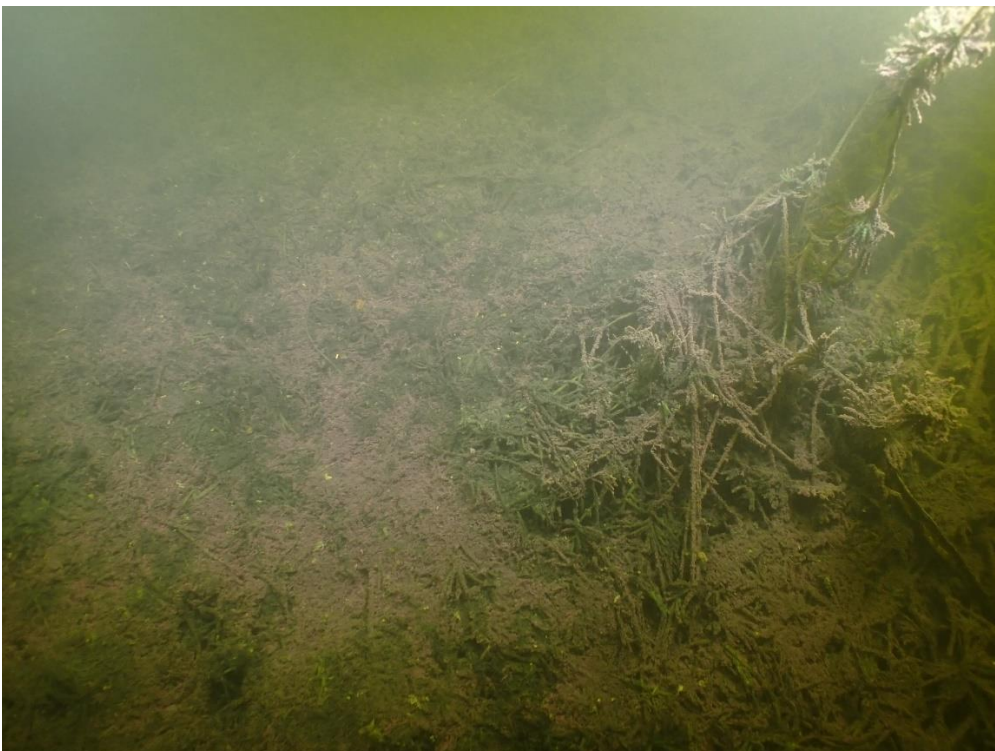
Beneath this organic layer there was approximately half a meter of soft silt before more firm consolidated sediment was felt. From 6.7 to 7.5 m deep (approx. 20 – 25 m from shore) the sediment firms up and has a coarser grain size with a surficial layer of organic silt. Signs of anoxia and benthic algal mats were seen throughout the survey area, particularly within the invasive macrophyte beds and along the lower bed boundary (>6 m).

Image 13: Patches of benthic algal growth amongst the decomposing organic material

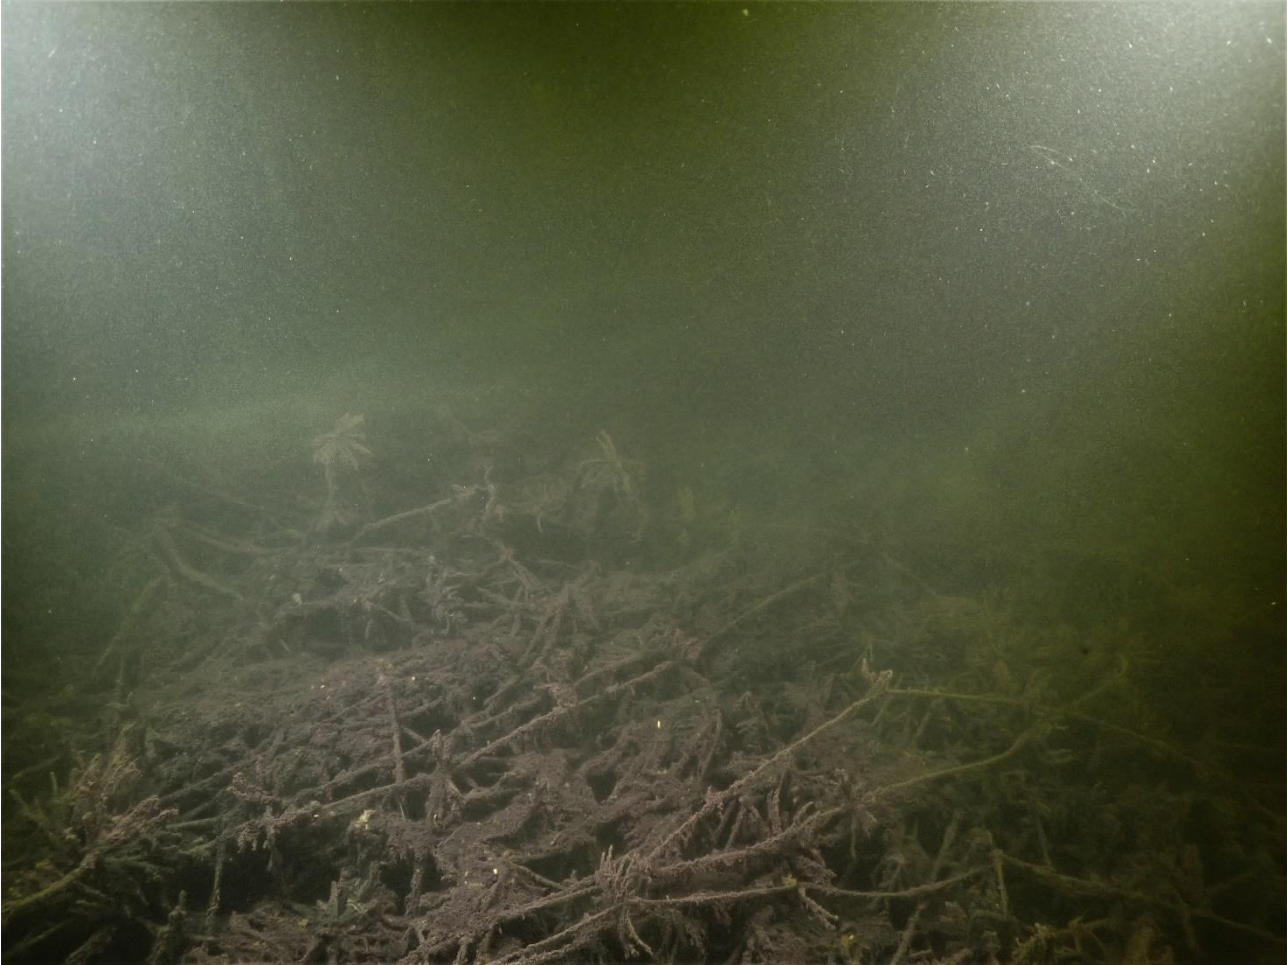
Dead macrophyte material releases phosphorus readily and eventually nitrogen (Pomogyi, Best, Dassen and Boon, 1984). Elevated total Phosphorus, total nitrogen, ammonia, total organic carbon and conductivity are commonly measured in the overlying water above decaying macrophytes (Si et al., 2020). This decomposition process also stimulates bacterial metabolism which consumes oxygen and releases carbon dioxide, this causes a drop in pH and dissolved oxygen concentration (Si et al., 2020). This anaerobic decomposition promotes the release of labile sulphur which contributes to the visible precipitate (Wium-Andersen, Anthoni and Houen, 1983). A sulphurous layer was seen in the overlying water above the decomposing Hornwort and in some areas this layer was seen as shallow as 5 m. The persistence and extent of this sulphurous layer is unknown, but it is likely that in-lake biodiversity would be affected by chronic exposure to this sulphur precipitate.

Image 14: Sulphur precipitate in the overlying water above decomposing organic material

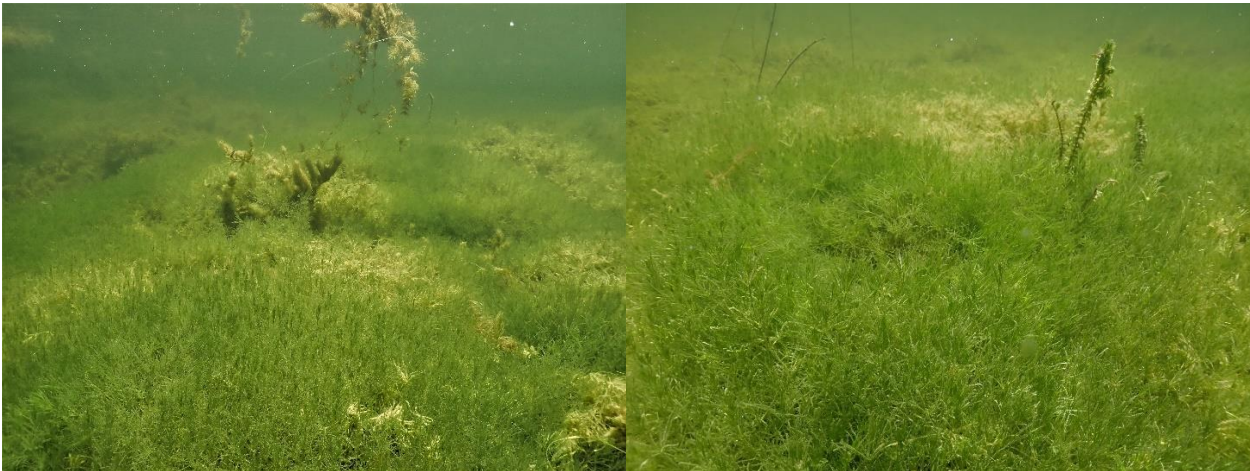
Both Hornwort and *Elodea* are faster growing and taller than native macrophytes. They can establish in the gaps between the stems of native species, this cause fragmentation of native macrophyte beds and creates tall stands of invasive species that shades out everything

Image 15: Stems of Hornwort and Elodea establishing amongst the native charophyte beds

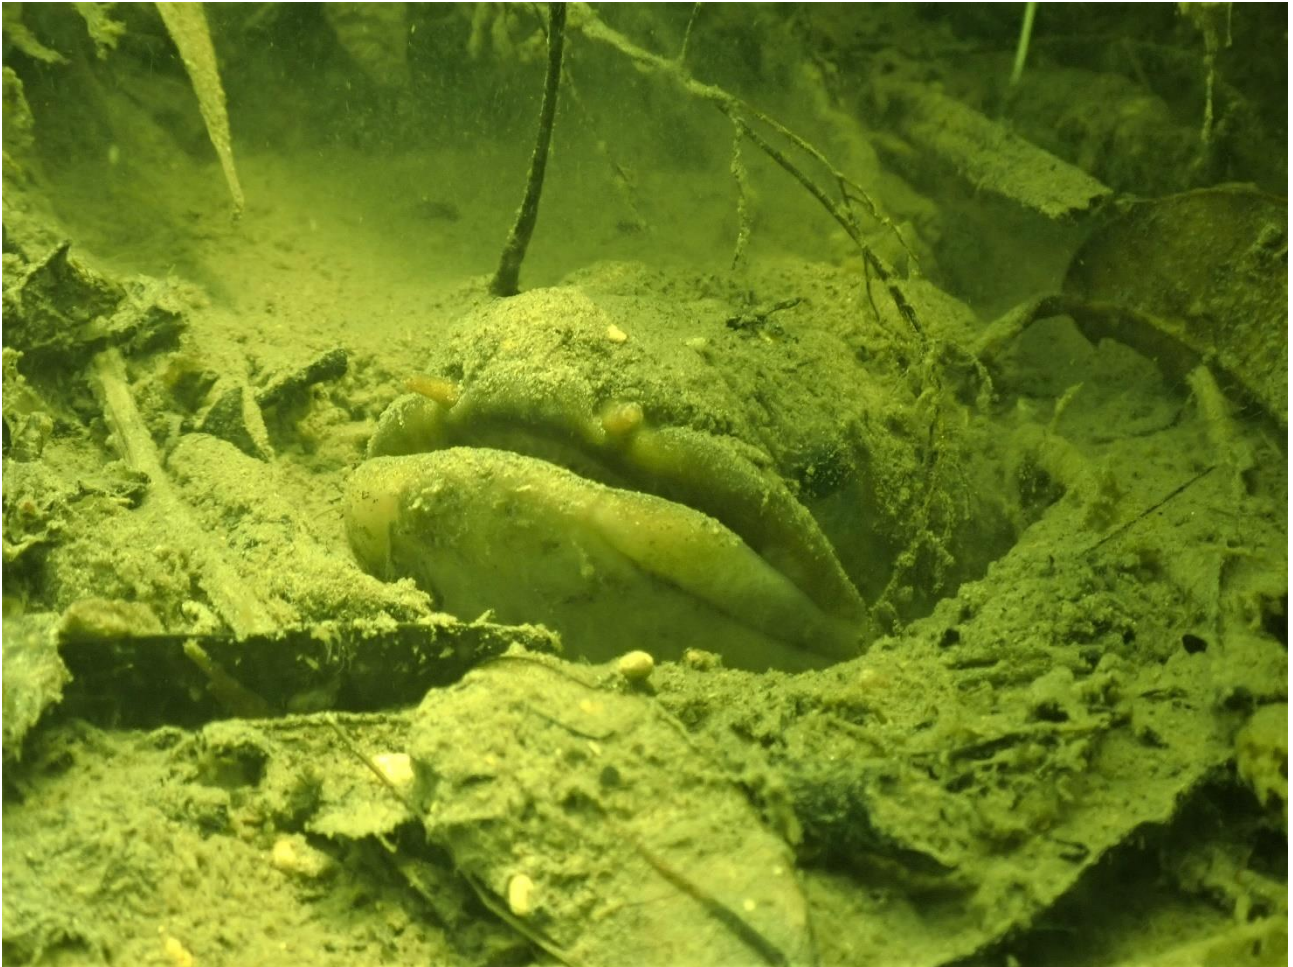
Only two in-lake vertebrates were sighted during the assessment, the first was schools of smelt (*Retropinna retropinna*) in the shallow areas around the Raupō. Several eels were sighted at a distance however due to the poor visibility it is unknown whether they are longfins or shortfins. Interestingly we observed an eel in the shallows (2 m depth) that was almost entirely buried in the sediment. Eels are known to bury themselves into the substrate and become inactive at temperatures around 10°C (Graynoth and Jellyman, 2002). Considering the extreme temperature difference in the lake with bottom water temperatures reaching 12°C it is plausible that this eel had buried itself in response to the cold.

Image 16: Eel buried in the sediment

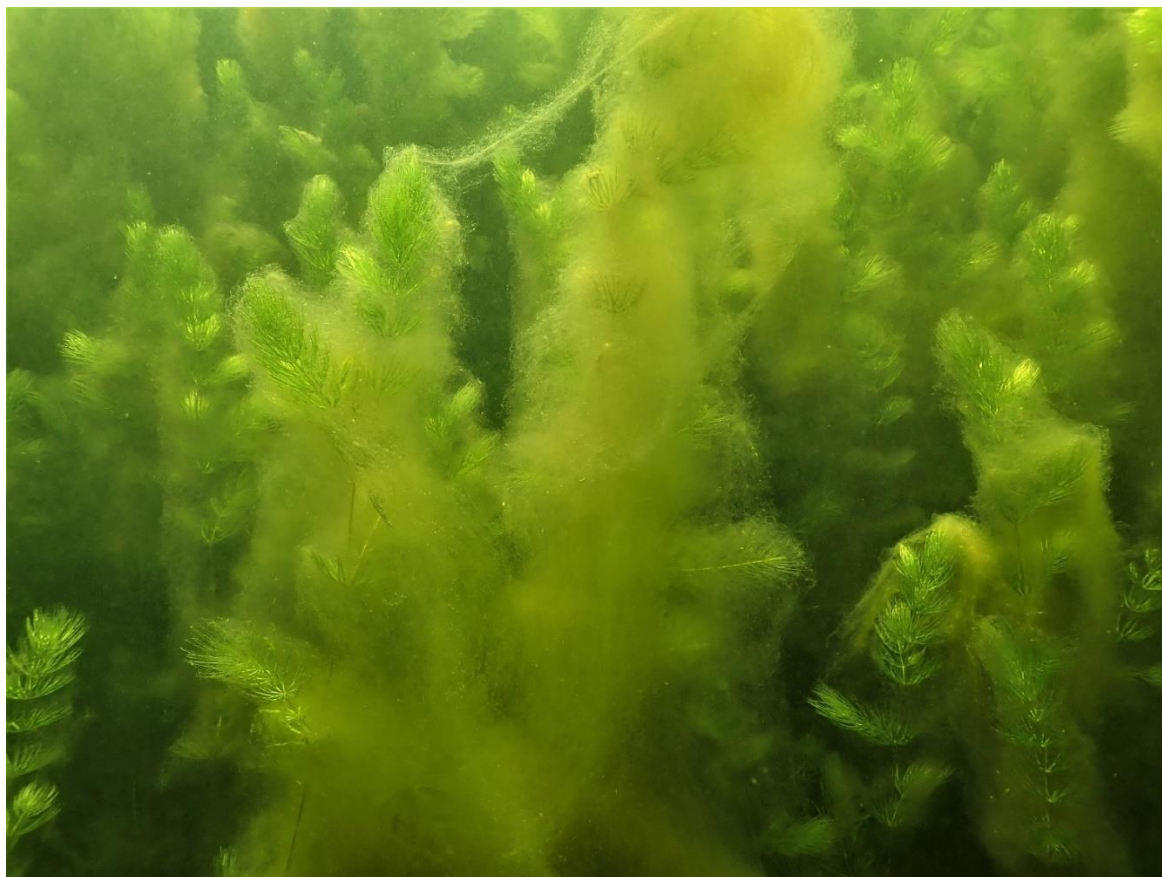
As mentioned above there were large sections of macrophytes covered by epiphytic algae. This epiphytic biofilm was most pronounced along a band between 3 – 4 m deep. The formation of epiphytic algae is likely limited by macrophyte shading and light availability which may explain why it was more prominent on the outer edge of the dense Hornwort beds at a specific depth.

Image 17: Large sections of Hornwort densely covered by epiphytic algae
