Lake Tikitapu

Qualitative Assessment

May 2022

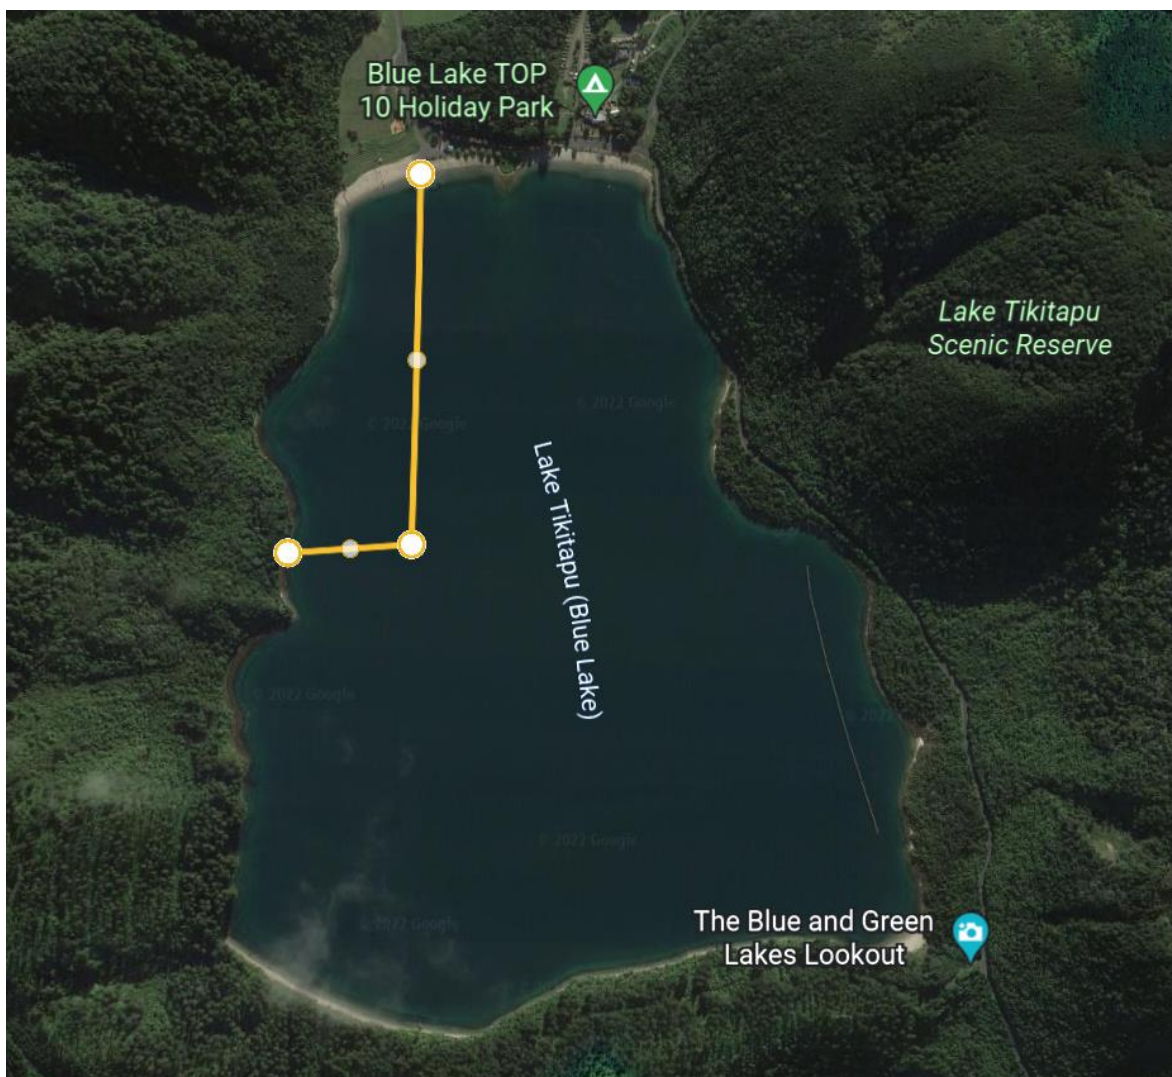
Figure 1: Survey area

On the 15th of May 2022 Aotearoa Dive hosted an event at Lake Tikitapu (Blue Lake) with the purpose of removing rubbish from the passive recreation areas. As part of this clean up dive Aotearoa Lakes completed a general observational survey across a portion of the western passive recreation area (Figure 1). The qualitative assessment focused on identifying discrete habitat types, signs of environmental impact, general lake health indicators, macrophyte species composition and macrophyte extent.

The survey area was largely confined to the portion of the western passive recreation area closest to the boat ramp (Figure 1). The assessment involved traversing three main depth contours: the deep contour (10 – 15 m), mid contour (5 – 9 m), shallow contour (1 – 4 m). These zones were delineated based on an initial transect from shore toward the center of the lake and represent the littoral, limnetic and benthic zones. The maximum depth was limited to 15 m due to the constraints of operating within the passive recreation areas.

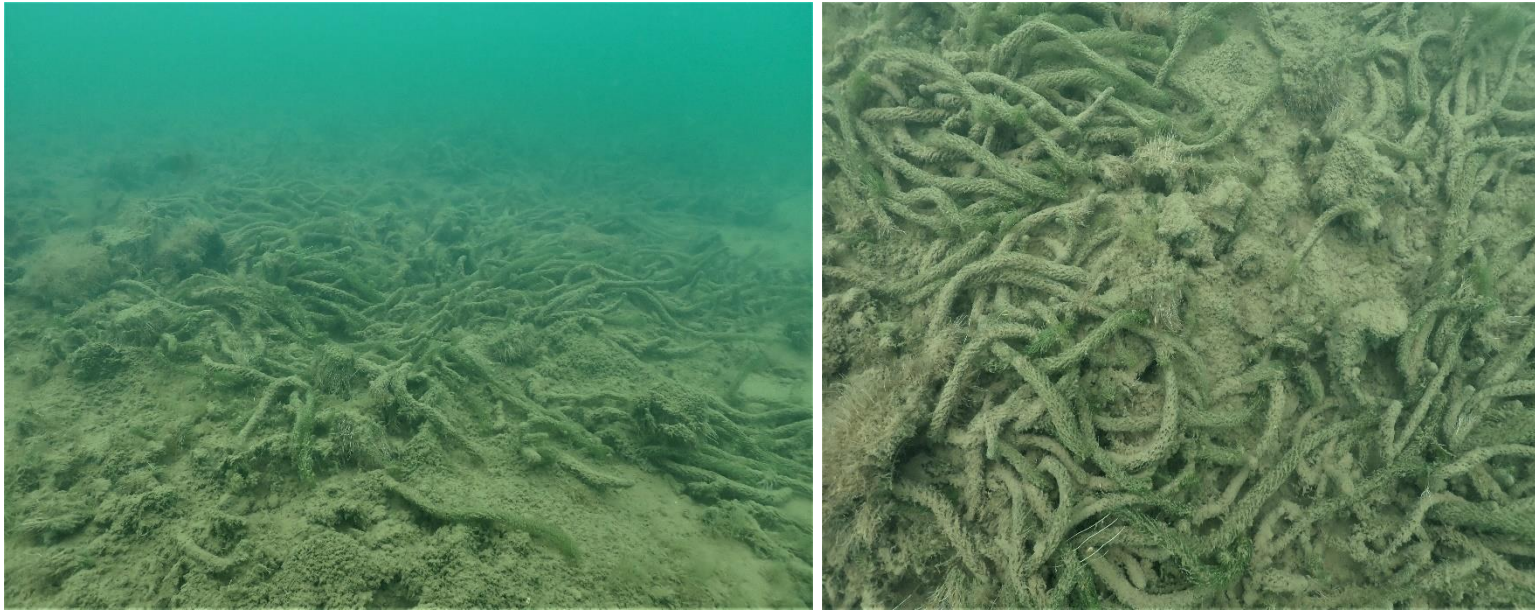
The shallow contours (1 – 4 m) ranged from flat to gently sloped toward the east. The substrate in this zone was sandy with a medium (0.2 – 0.63 mm) to fine (0.063 – 0.2 mm) grain size, there were areas with a coarse grain size (0.63 – 2.0 mm). There was a thin surficial layer of silt (0.002–0.0063 mm) across majority of this zone. The upper extent of this zone (1 - 2 m) had a thick layer of silt which was particularly pronounced in and above areas with dense *Lagarosiphon major* growth (Figure 2). This excessive deposition of fine silt is likely due to the dense macrophyte beds attenuating incoming fine sediment from the surrounding catchment. The relatively flat bathymetry in this zone facilitates great sediment deposition so a finer substrate grain size and surficial silt is to be expected. Large amounts of organic matter were observed between 1 – 2 m, majority of which consisted of decomposing *Lagarosiphon major* (Figure 2).

Figure 2: Sedimentation and decomposing Lagarosiphon in the shallows

The shallow sections of the littoral zone (1 – 4 m) are dominated by invasive *Lagarosiphon major* with small clumps of native *Nitella* species (*Nitella pseudoflabellata* and *Nitella leonhardii*) sporadically dispersed amongst the *Lagarosiphon* beds. The *Lagarosiphon* growth started in 0.5 m and extended to a maximum depth of 4.5 m with dense coverage between 1 – 4 m (Figure 6). *Lagarosiphon major* is typically a tall growing macrophyte but in Lake Tikitapu it appears to be heavily stunted (Figure 7), this stunted growth pattern has been attributed to low alkalinity, calcium, and silicon levels in the lake. Their shallow maximum depth extent is likely a result of the stunted growth, stems cannot grow taller to exploit the deeper sections of the lake. Sections of the *Lagarosiphon* bed in the shallows (0.5 – 3 m) was smothered by a thick layer of fine silt (Figure 2).

There were no alarming signs of environmental impacts however subtle indicators were observed. There was a noticeable build up of silt in the shallow (0 – 3 m) and in some areas this silt had smothered large sections of *Lagarosiphon*. A surficial layer of silt and mud was present across the survey area indicating a degree of sedimentation is occurring.

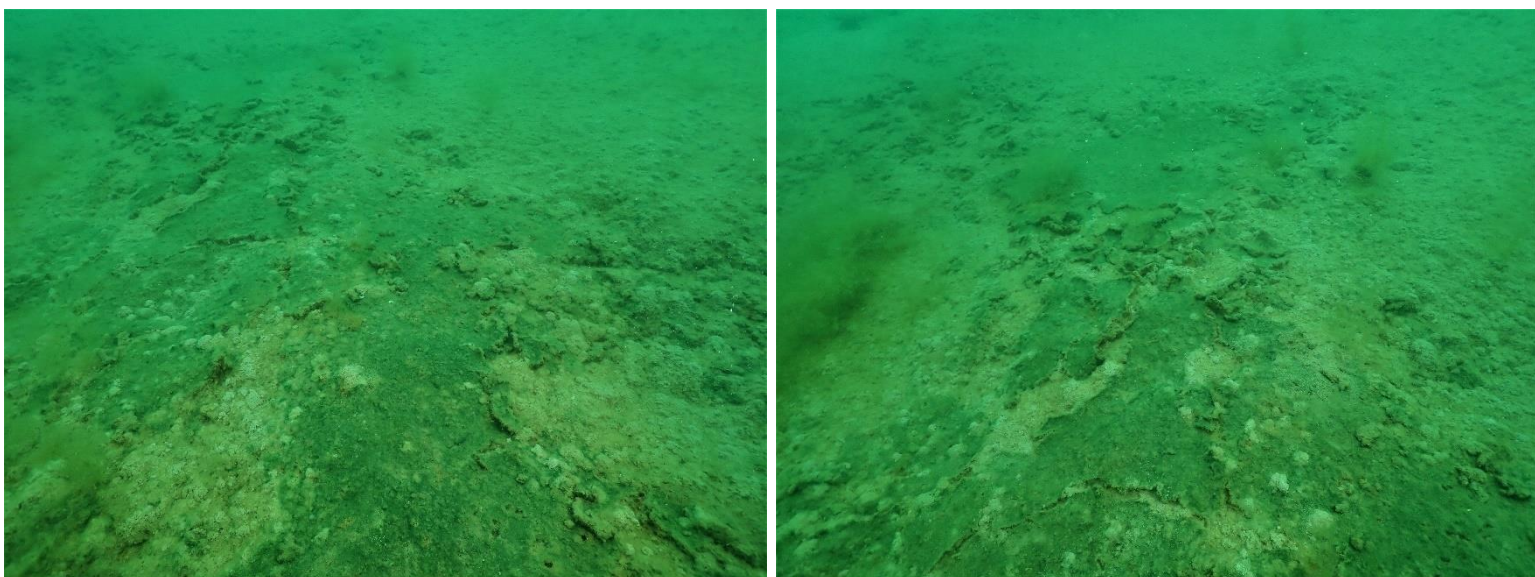
The mid contours (5 – 9 m) had a steep bathymetric slope toward the east (center of the lake). The substrate in this zone was similar to the shallower zone with a medium (0.2 – 0.63 mm) to fine (0.063 – 0.2 mm) grain size and thin surficial layer of silt (0.002–0.0063 mm). There was very little deposition of fine silt and clay in this zone, presumably due to the steep sloping. Large sections of this zone were covered by benthic algal mats (Figure 3). These mats are commonly associated with nutrient enrichment, but it is surprising that they were not observed in the shallower areas. Their absence from the shallows could be a result of wind induced scouring. Persistent winds mobilize fine sediment which cause a scouring effect along the lakebed in the shallows. This scouring could be responsible for preventing large scale benthic algal mat development.

Figure 3: Benthic algal mats along the mid contours

There were areas of the lakebed with a high percentage cover of benthic algal mats, while these mats are common in most mesotrophic lakes, they can be a good indicator of nutrient enrichment. It is hard to tell the full extent of these algal mats until summer where they are more prolific. The more concerning observation was the almost 100% cover of native macrophytes by epiphytic algae. This reason for the prolific epiphytic growth and its apparent host specificity is unknown. Epiphytic algae are commonly associated with nutrient enrichment and could be used as an indicator of eutrophication. An assessment during the summer months would be helpful in understanding the extent and effect this epiphyton is having on the native macrophytes.

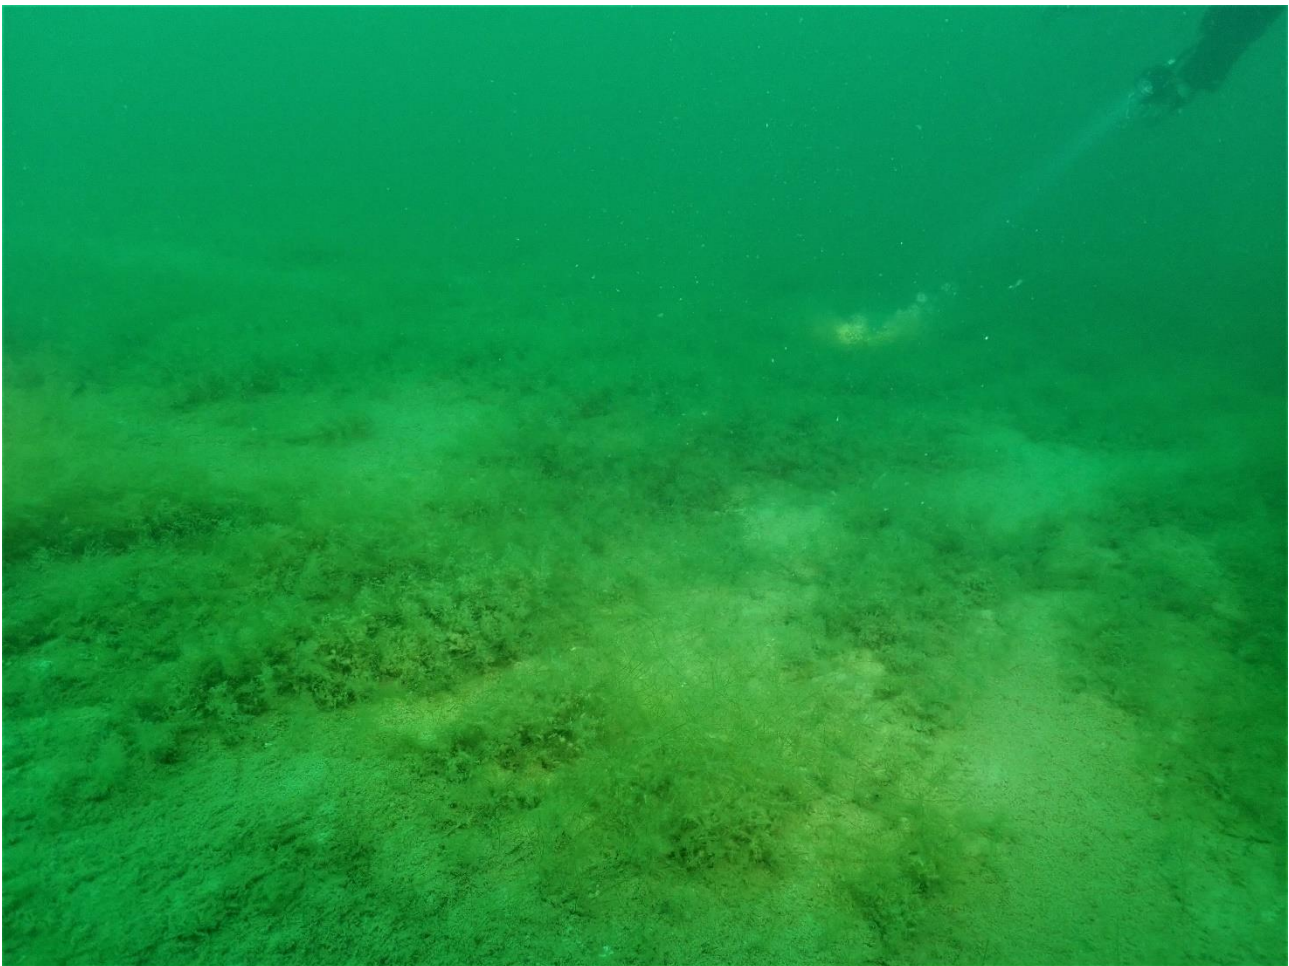
The deep contours (10 – 15 m) started at the base of the sloping mid contours and had a flat bathymetric slope that extended out toward the center of the lake. Being at the base of a slope this flat area is considered as a depositional zone. This zone was also dominated by native macrophyte beds which aid in the attenuation of fine sediment (Figure 4). As a result, the underlying substrate had a medium (0.2 – 0.63 mm) to fine (0.063 – 0.2 mm) grain size with sections of thick surficial silt, particularly in and around the macrophyte beds (Figure 4). Large banks of clay/mud like deposits were noted at 8 - 10 m, these deposits formed a network of shelves that native fauna use as cover (Figure 5). Sporadic benthic algal mats were noted but the overall cover was significantly lower than mid contours. This may be a result of the extensive macrophyte growth in the area.

Figure 4: Nitella beds along the deeper contours (silt accumulation can be seen around the edges of the beds)

The flat contour between 12 – 14 m had extensive *Nitella* beds (*Nitella pseudoflabellata* and *Nitella leonhardii*) with an average of 51 - 75% cover (Figure 4). The true maximum depth extent for *Nitella* species is unknown as the survey was restricted to the passive recreation area and as a result a maximum depth of 15 m.

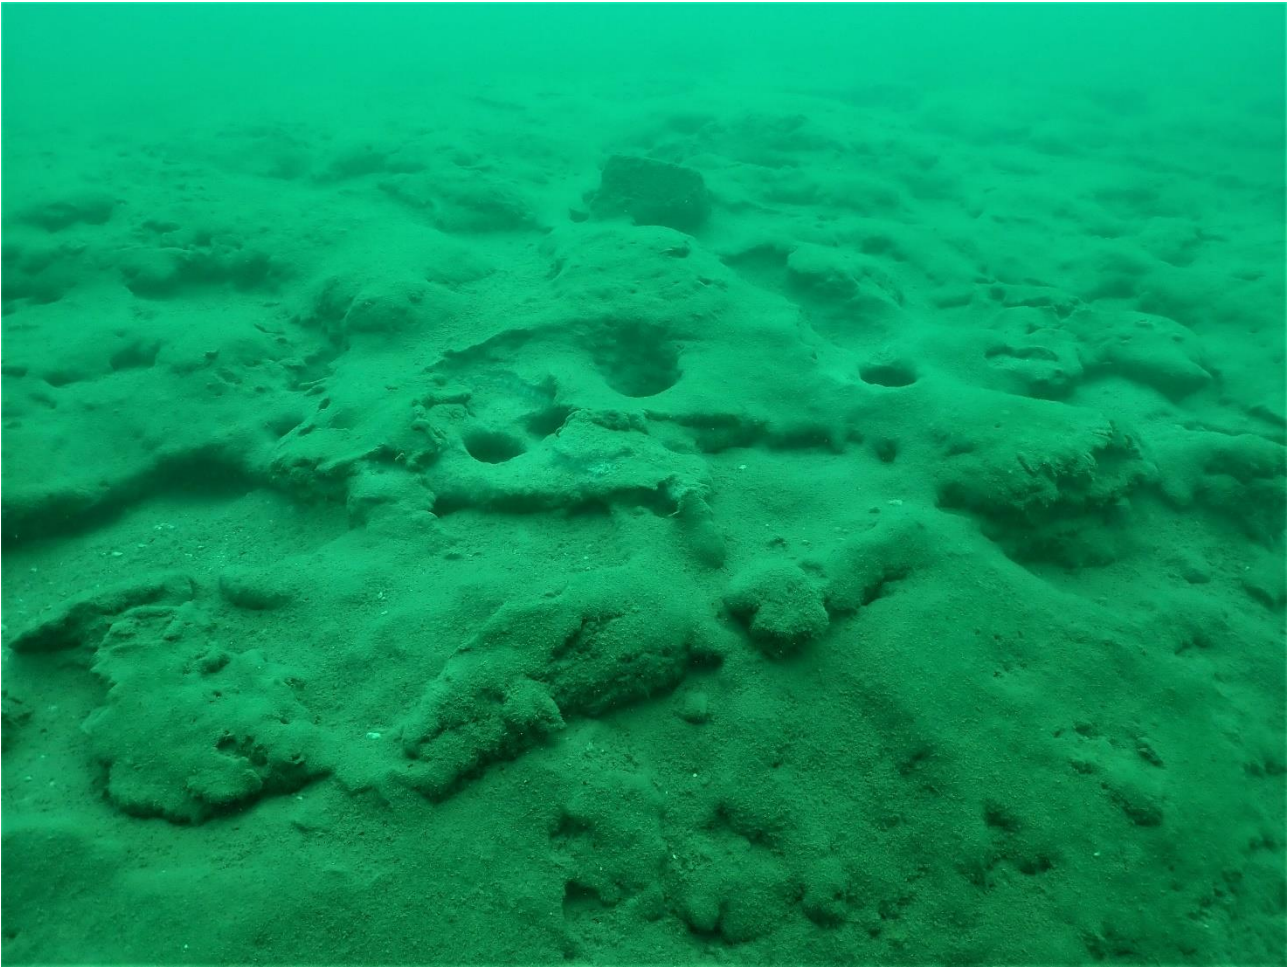
Figure 5: Mud banks at 8 - 10 m

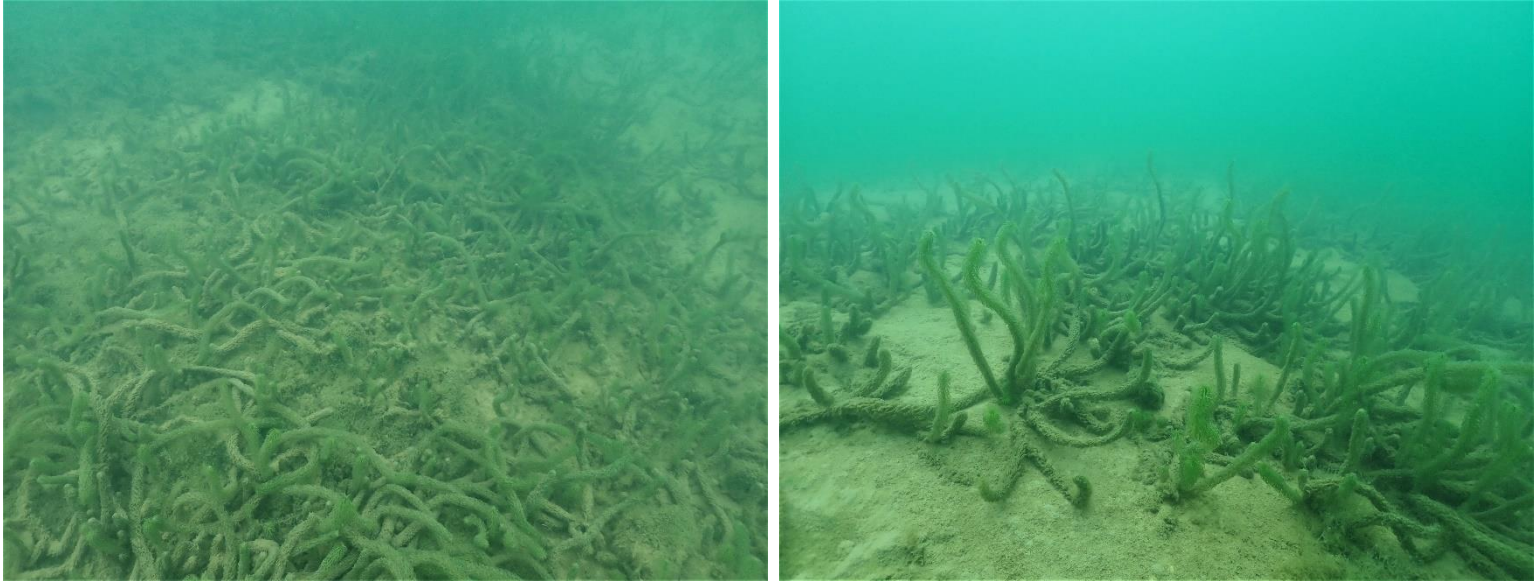
Figure 6: Dense *Lagarosiphon major* beds from 1 - 4m

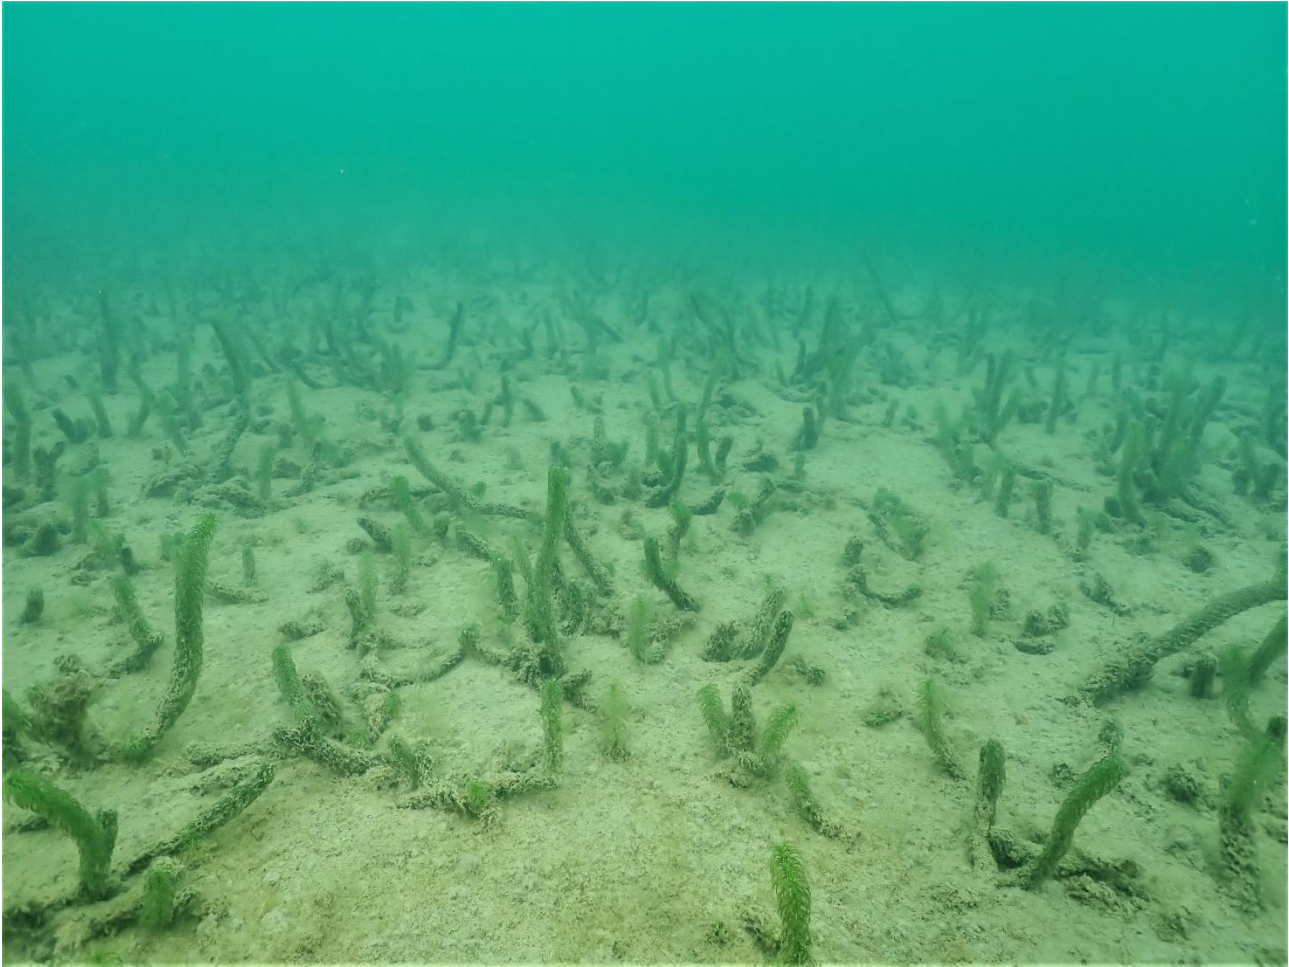
Figure 7: Stunted *Lagarosiphon major* in the shallows

The only invasive species sighted during the survey was *Lagarosiphon major* which was stunted and confined to a very narrow depth range (1 – 4.5 m). This means the total biomass is likely to remain stable provided the water quality does not deteriorate. This invasive species has displaced native macrophytes from the shallow margins and will contribute to the organic matter load in the lake but, considering the total biomass appears to be small relative to the lake size the impacts are likely to be limited.

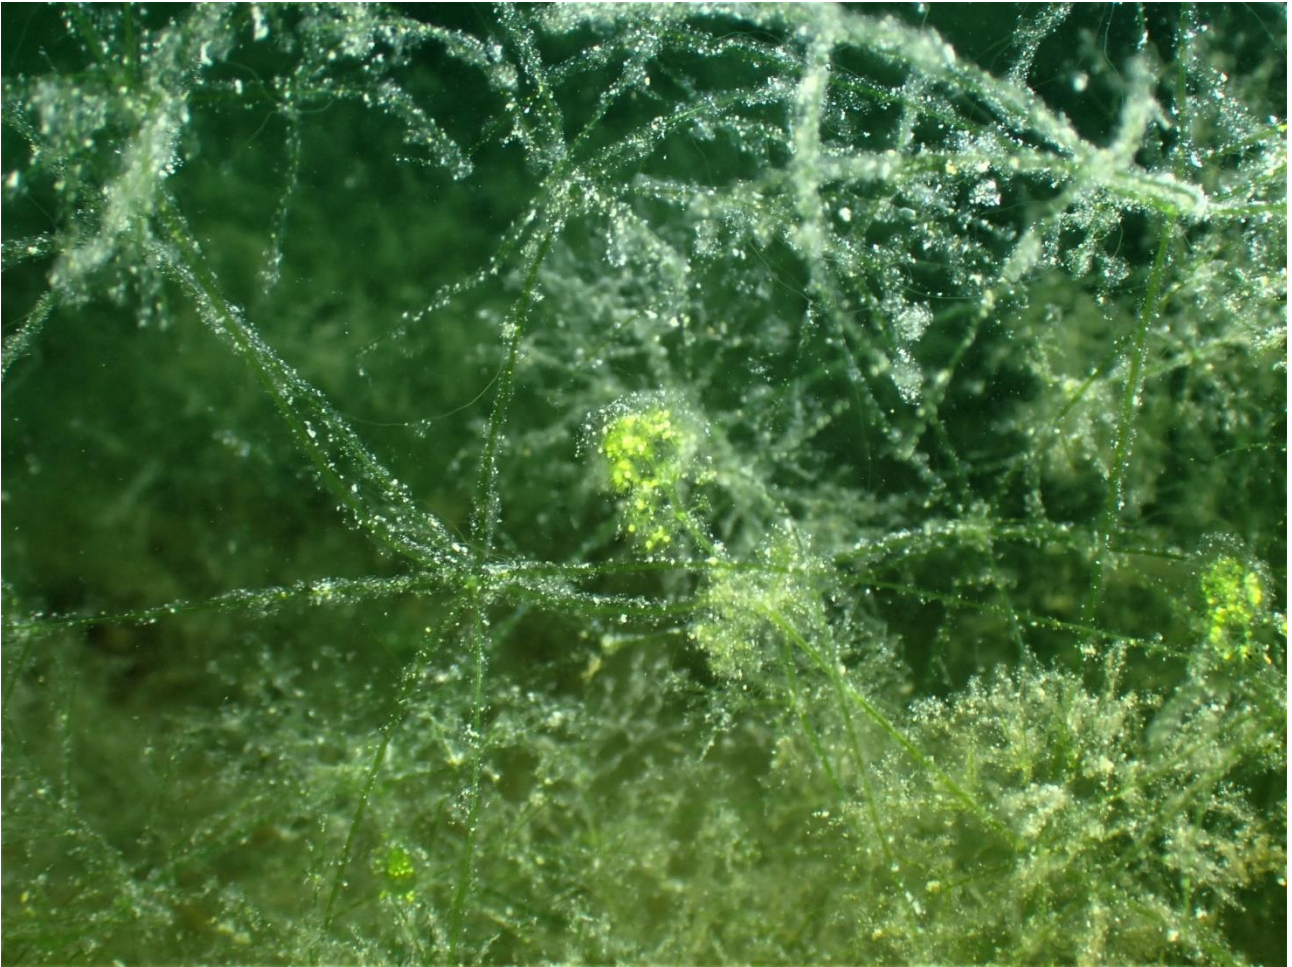
Epiphytic algae can reduce the intensity and quality of light able to be absorbed by the macrophyte host and they also compete for nutrients. In this way the epiphytic growth could contribute to regulating *Nitella* extent in Lake Tikitapu. Despite being smothered by epiphytic algae fruiting bodies were commonly seen on the terminal ends of *Nitella* (Figure 10).

Figure 10: Fruiting body of Nitella

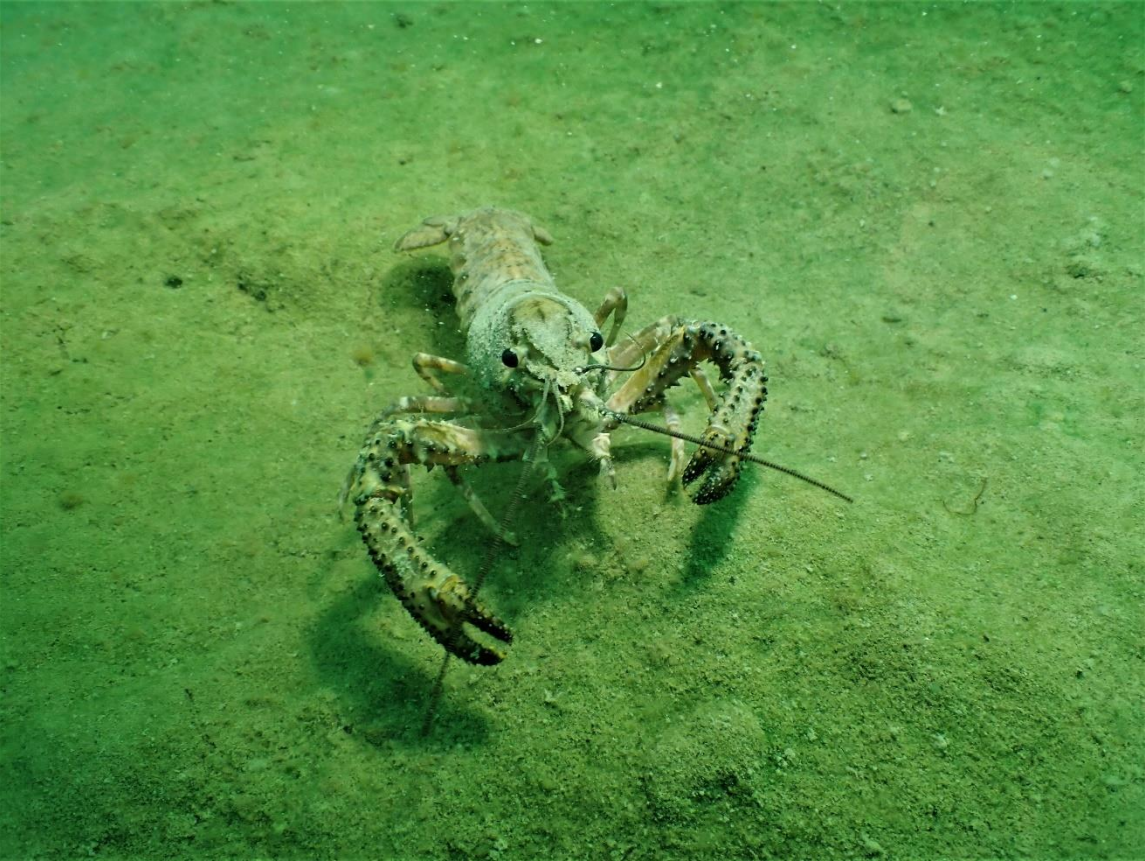
The only macro fauna sighted during the survey was common bullies (*Gobiomorphus cotidianus*) and kōura (*Paranephrops planifrons*) (Figure 11). Small numbers of common bullies were observed in the shallows amongst the dense *Lagarosiphon major* beds. Only the odd individual was seen in the open lakebed along the mid contours (5 – 9 m), this is a result of the lack of cover in this zone. Large schools of bullies were seen along the deeper depths, particularly in/around the Nitella beds (12 – 14 m) and mud banks (7– 9 m) (Figure 12). The bullies use the Nitella beds as cover in the otherwise barren environment. The mud banks at the base of the sloping mid contours (7 – 9 m) have a network of undercuts, tunnels and holes (created by kōura) that provided refugia for bullies (Figure 13).

Figure 11: kōura (*Paranephrops planifrons*)

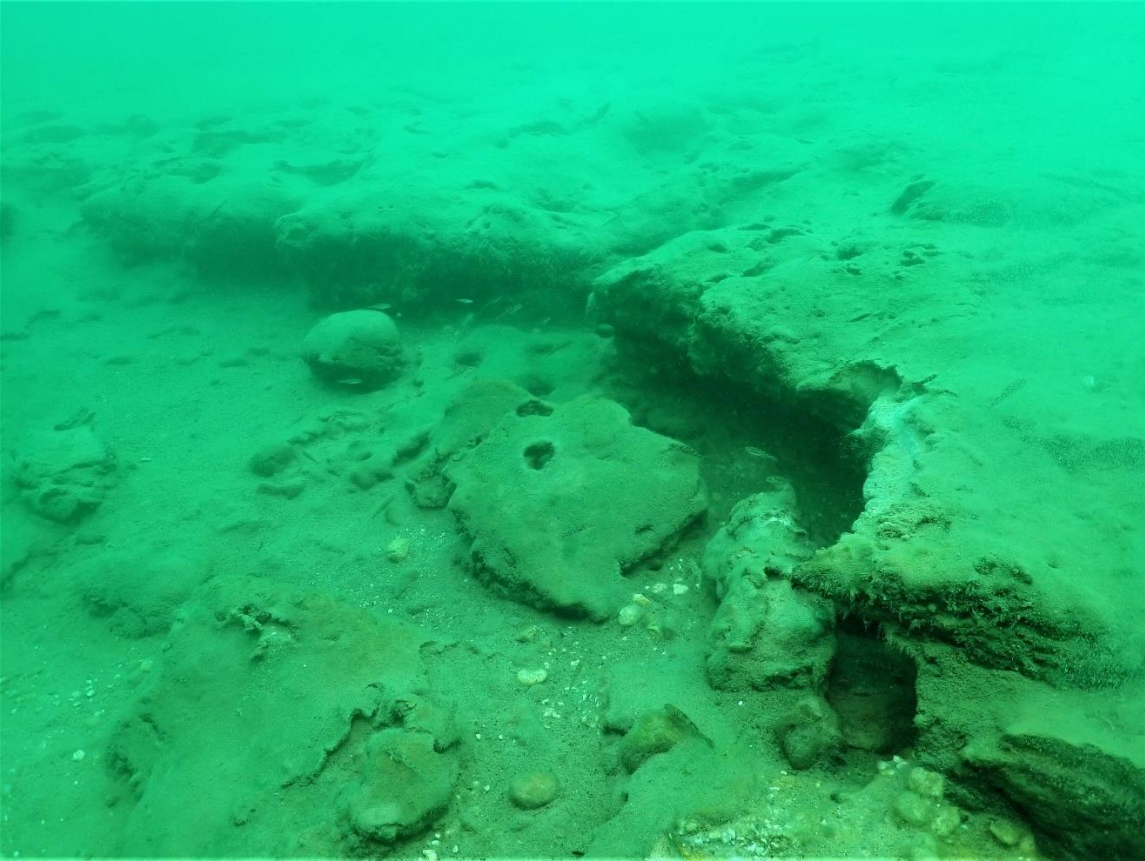
Figure 12: Bullies schooling along the mud banks

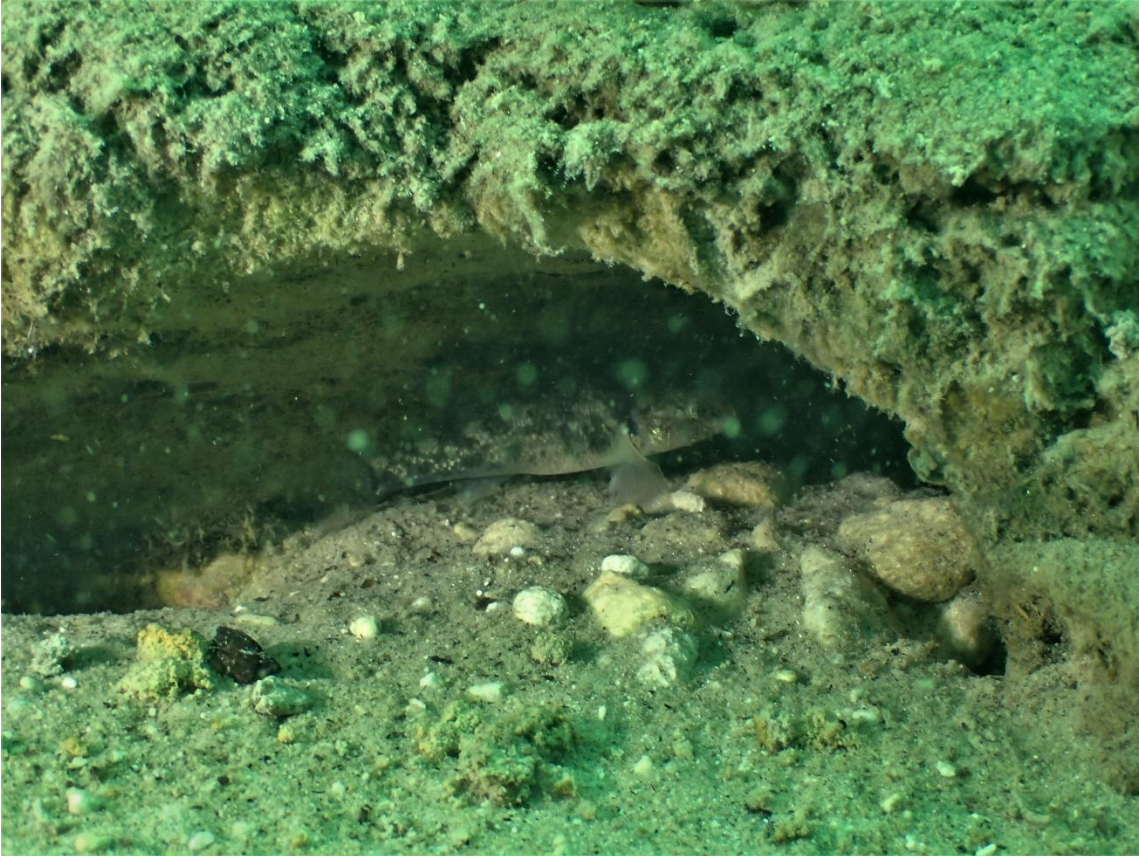
Figure 13: Common bully (*Gobiomorphus cotidianus*) hiding in the undercuts of the mud bank

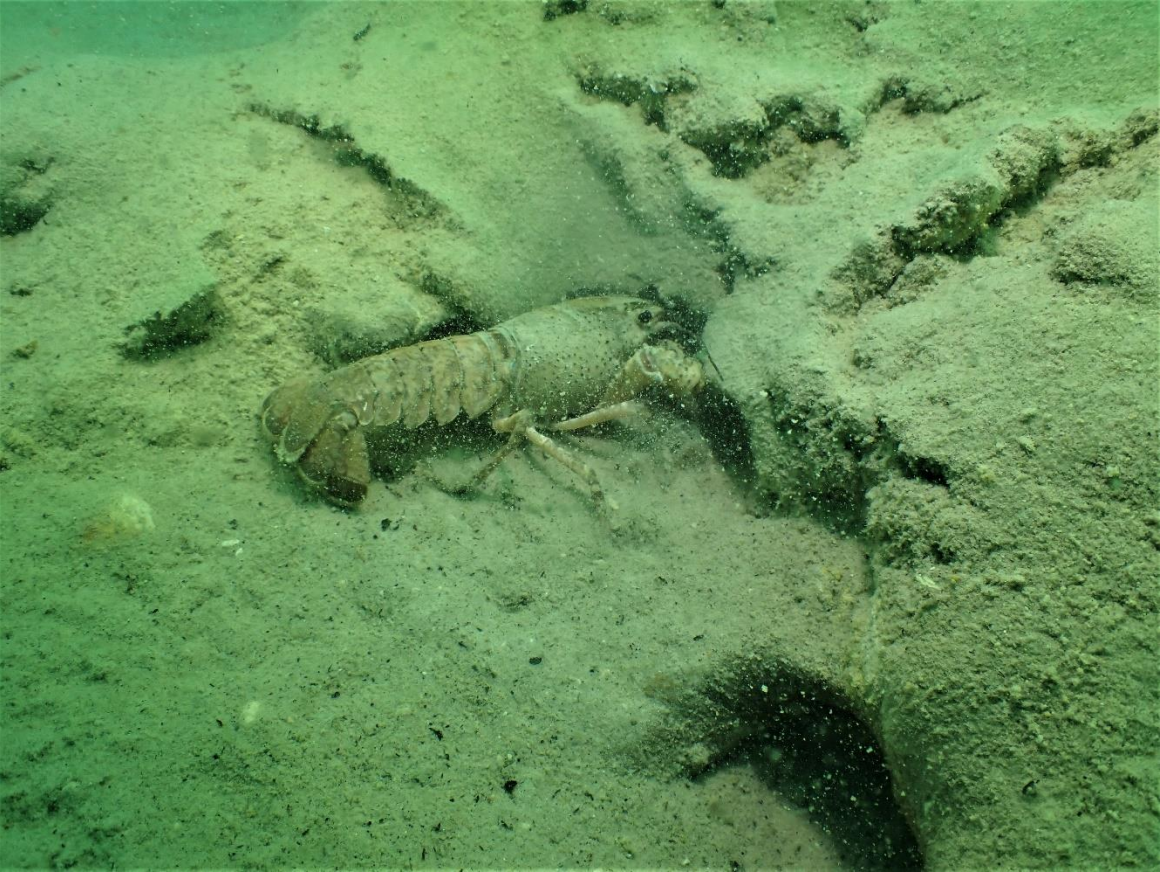
Large numbers of kōura were seen in burrows and tunnels along the mud bank at the base of the mid contours (7 – 9 m) (Figure 14 & 15), this was the only refugia seen outside the macrophyte beds. Individual kōura were occasionally seen walking across the open sections of lakebed and amongst the deep *Nitella* beds. No kōura were sighted amongst the shallow *Lagarosiphon* beds.

The mud banks at 7 - 9 m held the highest numbers of in-lake fauna and clearly serves as an important habitat space. This area is a depositional zone which creates the ideal substrate characteristics for burrowing, organic matter is also deposited in this zone and provides a valuable food source for both bullies and kōura.

Figure 14: Kōura emerging from a tunnel

Figure 15: Kōura digging a tunnel into the mud bank
